Potomac Interceptor

INSPECTION REPORTS

DISTRICT OF COLUMBIA WATER AND SEWER AUTHORITY

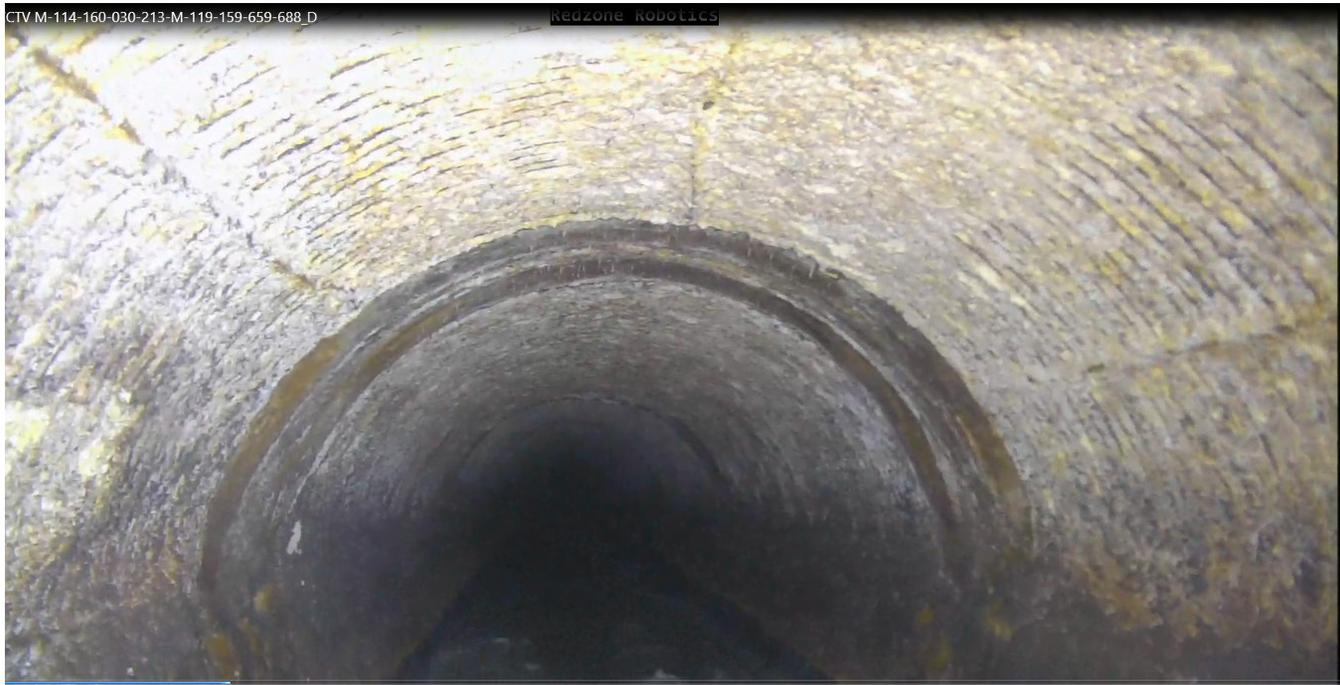
3. Inspection at Break

(OCTOBER 2024, 168' TO 184' DOWNSTREAM OF MH17)

- In the break zone between 168' and 184' downstream of MH17, the video shows exposed aggregate in the concrete and surface reinforcement visible, but no other significant pipe defects.

Exposed aggregate in the concrete and surface reinforcement visible were the internal pipe conditions observed in the inspections in the estimated break area which is 168’ to 184’ downstream of MH 17, which were not indicative of a risk of near-term failure of the asset.

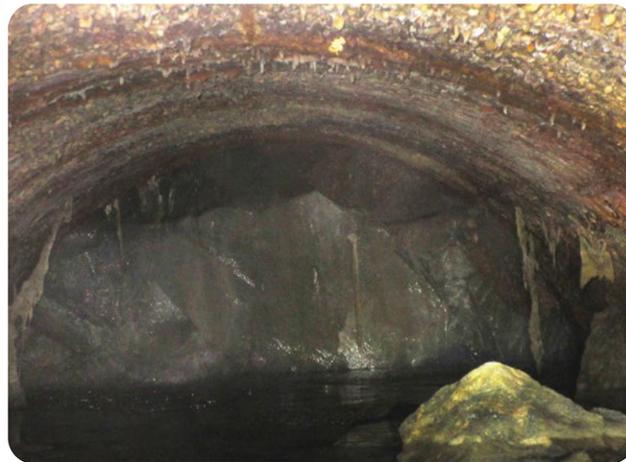
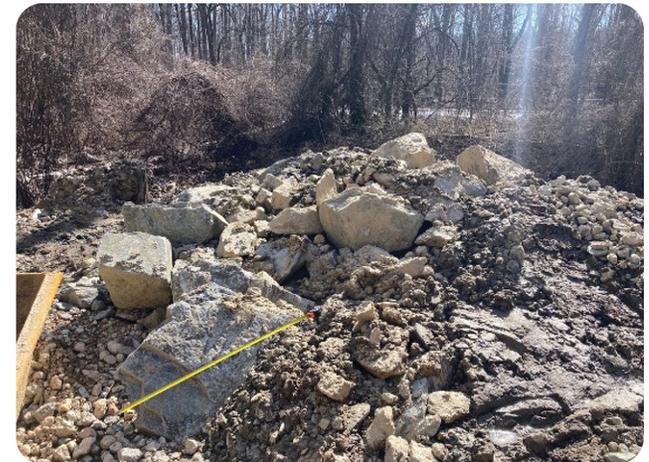
Boulders in Trench Backfill Created "Once in Lifetime" Pipe Blockage

- Large boulders observed in pipe and in trench backfill (30"+ in size)
- Not a normal or acceptable practice
- Typical pipe failures **do not** cause nearly complete blockage that occurred here

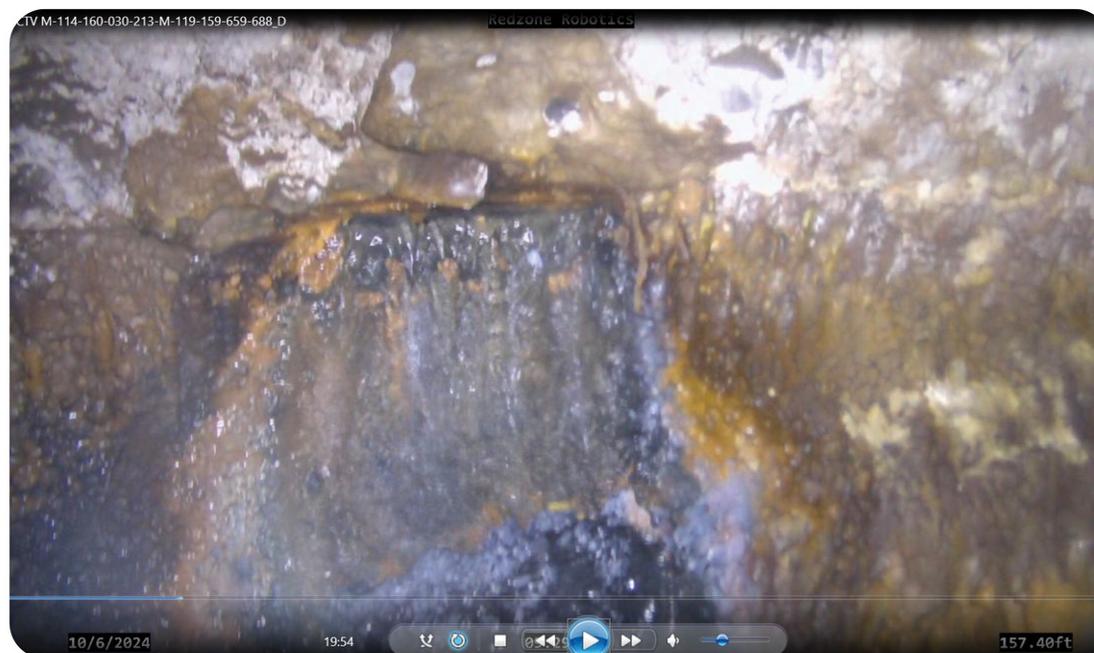
CCTV: 157.4' – “Hole Void Visible,” Structural Grade 5 Incorrect, Do Not See Hole in Video

In June 2024, this defect was identified as “infiltration gusher” with structural grade of 0. In October 2024, this defect was identified as “hole void visible” with structural grade of 5.

- October 6, 2024
 - Report contents:
 - 147.8', 164.6' and 195.6' - infiltration weepers, each with O&M ratings of 2.
 - 157.4' – this defect was an infiltration runner with an O&M grade of 4 that was also scored as a hole with a structural grade of 5. Based on review of the video, this is the same defect identified in the June 2024 report at 156.9' and the size and shape look similar to the June 2024 inspection. The infiltration observation is correct, but the 'hole void visible' assertion appears to be a misidentification. There is dark colored concrete above and around the infiltration area. This area has the surface texture of concrete, gray areas indicative of concrete, and has a tapered zone around the perimeter showing the transition in concrete thickness. This area is located between 10' and 26' upstream of the break area.

shows that this defect was misidentified and the dark area at approximately the 9 o'clock position is concrete pipe. This is supported by the following:

- As shown by the other infiltration weepers in the video, the pipe is subject to infiltration by groundwater. If the discolored area were soil, one would expect to see infiltration into the pipe at this location, which is not present in the video.

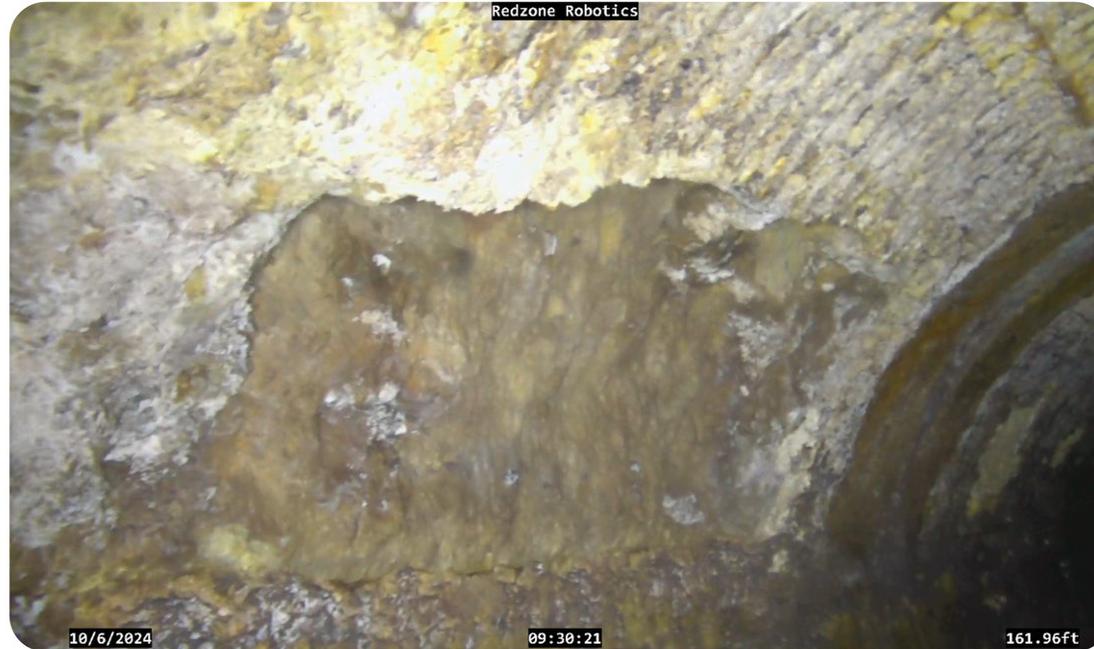
CCTV: 162' – "Hole Soil Visible," Structural Grade 5 Incorrect – Do Not See Soil in Video

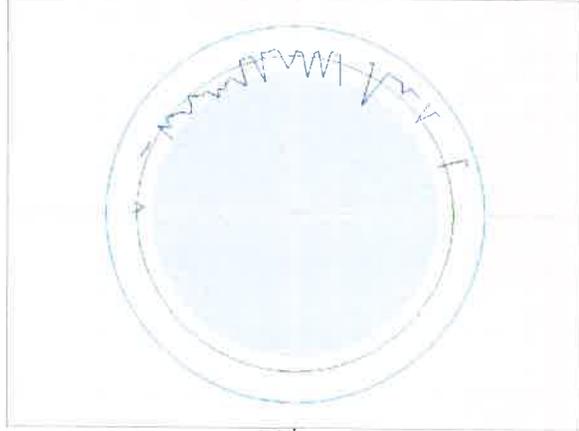
116.1ft Note - Laser distorted due to flow velocity and water on lens throughout the entire run

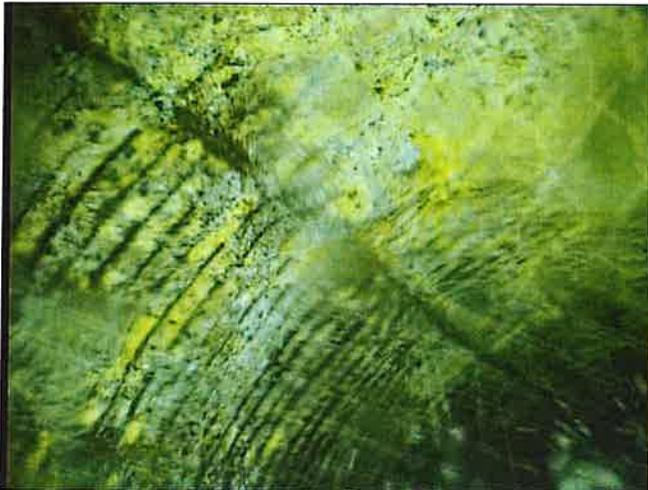
Code: **SRP**
Description: **Surface Damage Reinforcement Projecting**

Distance (ft): **126.3**
Structural Grade: **5**
O&M Grade: **0**
Clock Start/From: **8**
Clock To: **4**
1st Value:
2nd Value:
Value Percent:
Continuous Index: **S01**
Within 8" of Joint: **NO**

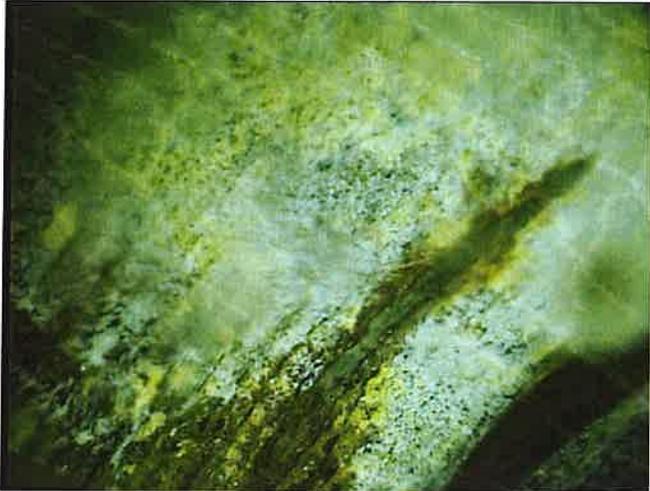
Code: **IS**
Description: **Infiltration Stain**

Distance (ft): **233.4**
Structural Grade: **0**
O&M Grade: **1**
Clock Start/From: **8**
Clock To: **4**
1st Value:
2nd Value:
Value Percent:
Continuous Index: **S02**
Within 8" of Joint: **NO**
Remarks:

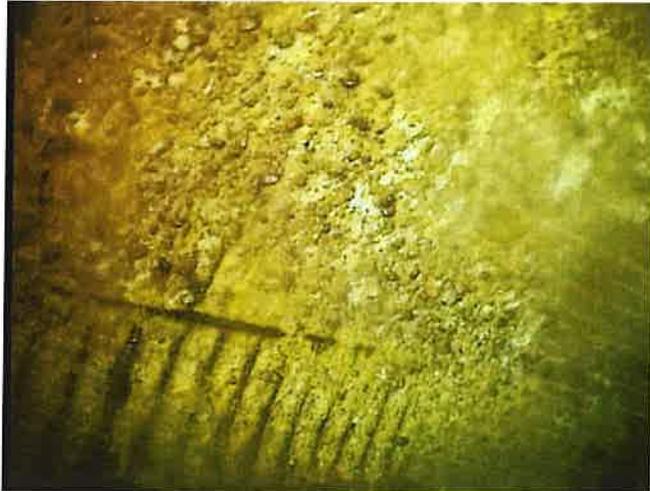
Code: **SRC**
Description: **Surface Damage Reinforcement Corroded**
Distance (ft): **520.4**
Structural Grade: **5**
O&M Grade: **0**
Clock Start/From: **8**
Clock To: **4**
1st Value:
2nd Value:
Value Percent:
Continuous Index: **F06**
Within 8" of Joint: **NO**
Remarks:

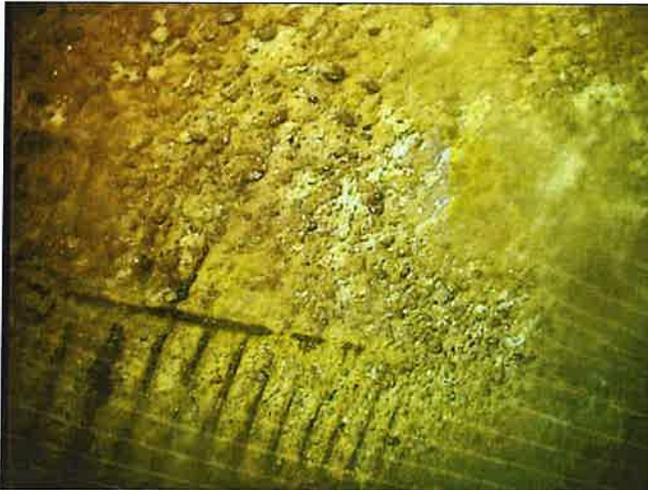
Code: **SRV**
Description: **Surface Damage Reinforcement Visible**
Distance (ft): **520.4**
Structural Grade: **4**
O&M Grade: **0**
Clock Start/From: **8**
Clock To: **4**
1st Value:
2nd Value:
Value Percent:
Continuous Index: **S03**
Within 8" of Joint: **NO**
Remarks:

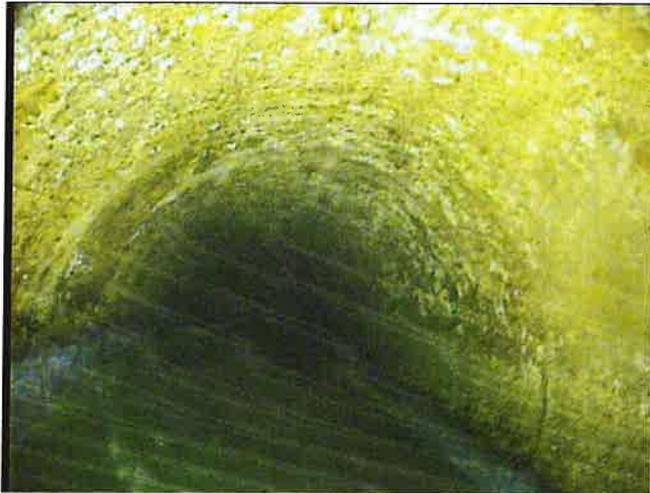
Code: **IS**
Description: **Infiltration Stain**

Distance (ft): **535.8**
Structural Grade: **0**
O&M Grade: **1**
Clock Start/From: **8**
Clock To: **4**
1st Value:
2nd Value:
Value Percent:
Continuous Index: **F02**
Within 8" of Joint: **NO**
Remarks:

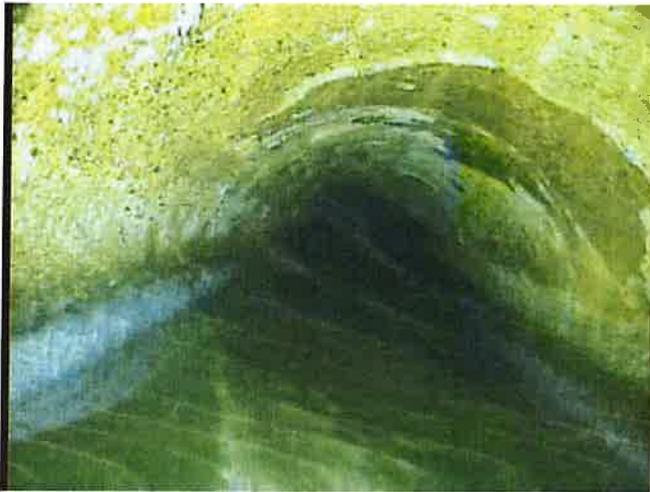
Code: **SRV**
Description: **Surface Damage Reinforcement Visible**

Distance (ft): **800.4**
Structural Grade: **4**
O&M Grade: **0**
Clock Start/From: **8**
Clock To: **4**
1st Value:
2nd Value:
Value Percent:
Continuous Index: **F03**
Within 8" of Joint: **NO**
Remarks:

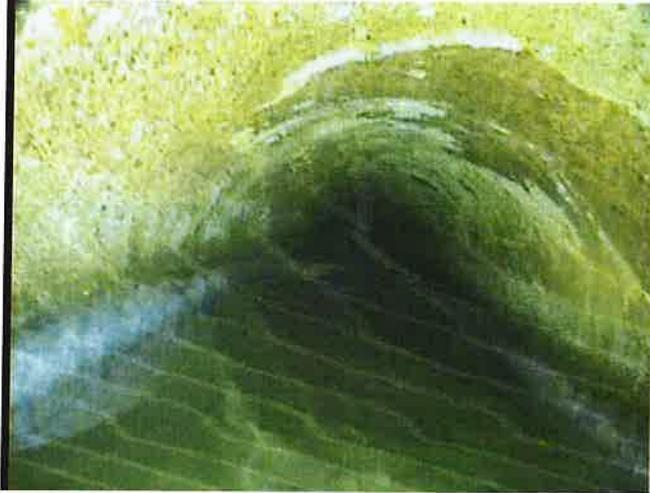
Code: **SAP**
Description: **Surface Damage Aggregate Projecting**

Distance (ft): **801.3**
Structural Grade: **3**
O&M Grade: **0**
Clock Start/From: **8**
Clock To: **4**
1st Value:
2nd Value:
Value Percent:
Continuous Index: **S07**
Within 8" of Joint: **NO**
Remarks:

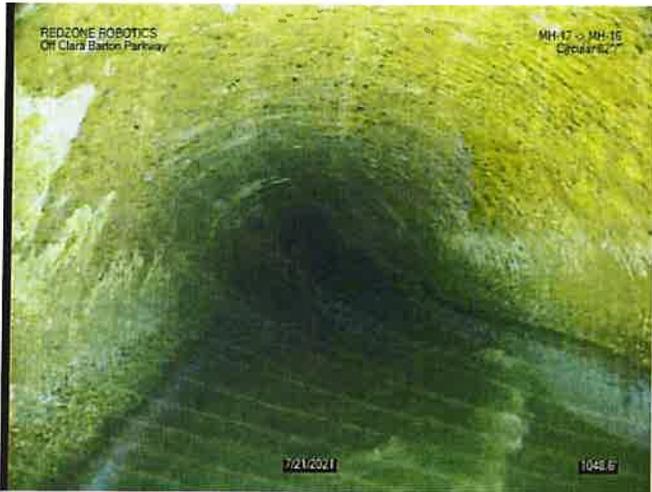
Code: **SRV**
Description: **Surface Damage Reinforcement Visible**

Distance (ft): **1048.6**
Structural Grade: **4**
O&M Grade: **0**
Clock Start/From: **1**
Clock To: **4**
1st Value:
2nd Value:
Value Percent:
Continuous Index: **S10**
Within 8" of Joint: **NO**
Remarks:

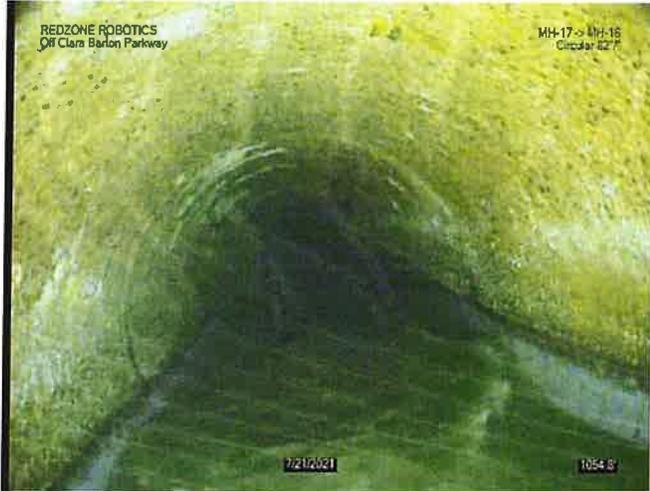
Code: **SRV**
 Description: **Surface Damage Reinforcement Visible**

Distance (ft): **1054.8**
 Structural Grade: **4**
 O&M Grade: **0**
 Clock Start/From: **1**
 Clock To: **4**
 1st Value:
 2nd Value:
 Value Percent:
 Continuous Index: **F10**
 Within 8" of Joint: **NO**
 Remarks:

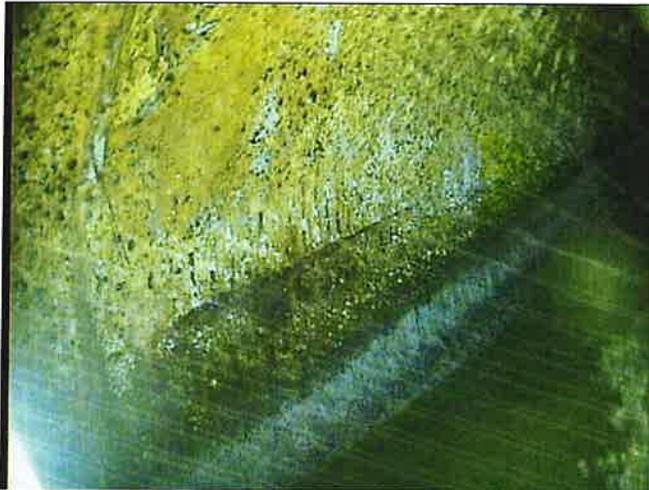
Code: **SRV**
 Description: **Surface Damage Reinforcement Visible**

Distance (ft): **1276.3**
 Structural Grade: **4**
 O&M Grade: **0**
 Clock Start/From: **8**
 Clock To:
 1st Value:
 2nd Value:
 Value Percent:
 Continuous Index:
 Within 8" of Joint: **NO**
 Remarks:

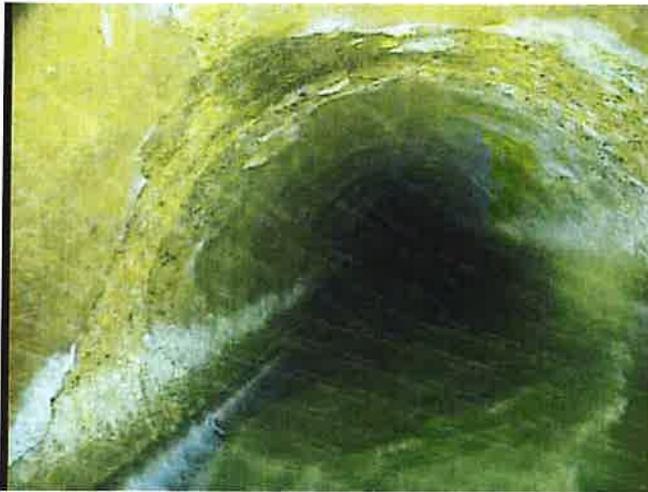
Code: **SAP**
Description: **Surface Damage Aggregate Projecting**

Distance (ft): **1626.0**
Structural Grade: **3**
O&M Grade: **0**
Clock Start/From: **8**
Clock To: **4**
1st Value:
2nd Value:
Value Percent:
Continuous Index: **F07**
Within 8" of Joint: **NO**
Remarks:

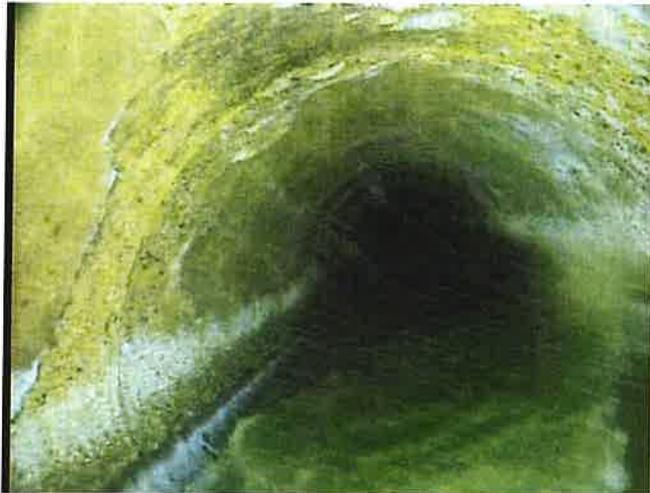
Code: **SAV**
Description: **Surface Damage Aggregate Visible**

Distance (ft): **1626.8**
Structural Grade: **2**
O&M Grade: **0**
Clock Start/From: **8**
Clock To: **4**
1st Value:
2nd Value:
Value Percent:
Continuous Index: **S08**
Within 8" of Joint: **NO**
Remarks:

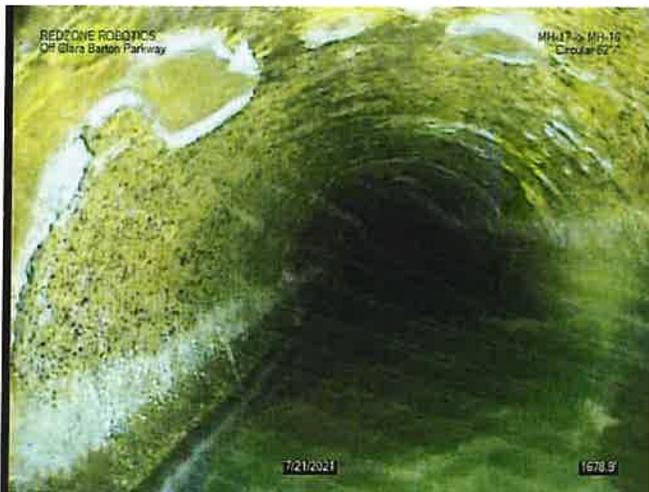
Code: **SAV**
Description: **Surface Damage Aggregate Visible**

Distance (ft): **1678.9**
Structural Grade: **2**
O&M Grade: **0**
Clock Start/From: **8**
Clock To: **4**
1st Value:
2nd Value:
Value Percent:
Continuous Index: **F08**
Within 8" of Joint: **NO**
Remarks:

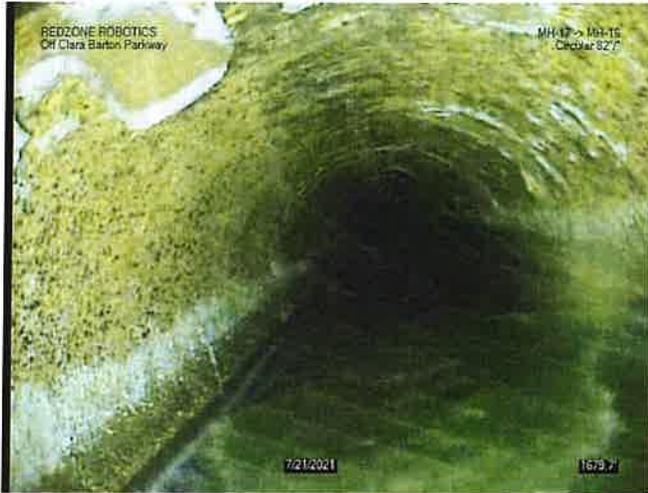
Code: **SAP**
 Description: **Surface Damage Aggregate Projecting**

Distance (ft): **1679.7**
 Structural Grade: **3**
 O&M Grade: **0**
 Clock Start/From: **8**
 Clock To: **4**
 1st Value:
 2nd Value:
 Value Percent:
 Continuous Index: **S11**
 Within 8" of Joint: **NO**
 Remarks:

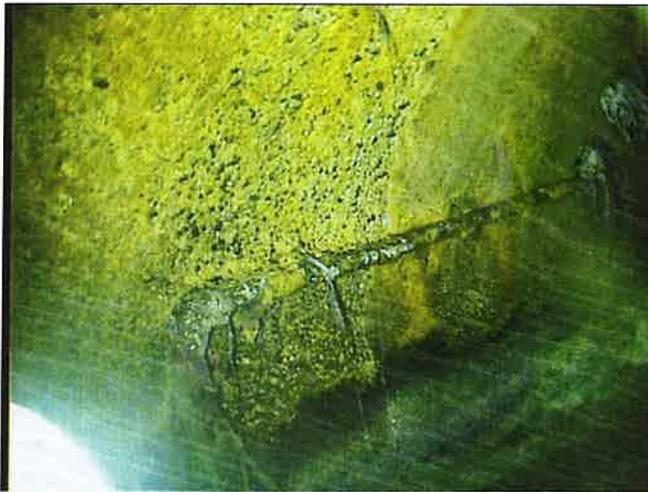
Code: **OBP**
 Description: **Obstruction External Pipe or Cable**

Distance (ft): **1853.8**
 Structural Grade: **0**
 O&M Grade: **2**
 Clock Start/From: **9**
 Clock To:
 1st Value:
 2nd Value:
 Value Percent: **5.000**
 Continuous Index:
 Within 8" of Joint: **NO**
 Remarks:

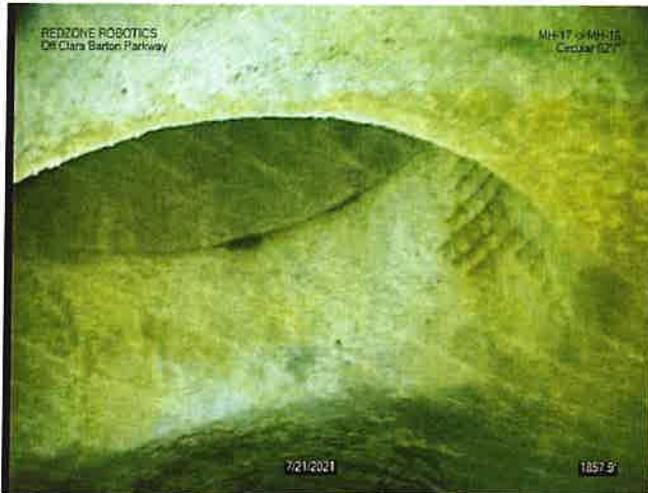
Code: **SAP**
 Description: **Surface Damage Aggregate Projecting**

Distance (ft): **1857.9**
 Structural Grade: **3**
 O&M Grade: **0**
 Clock Start/From: **8**
 Clock To: **4**
 1st Value:
 2nd Value:
 Value Percent:
 Continuous Index: **F11**
 Within 8" of Joint: **NO**
 Remarks:

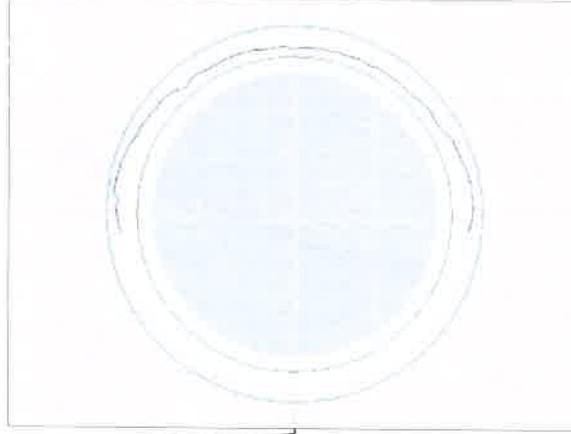
276.2ft Maximum Corrosion - To 6.1"
