# Potomac Interceptor MH410-MH411 Repair

Community Meeting • June 11, 2026

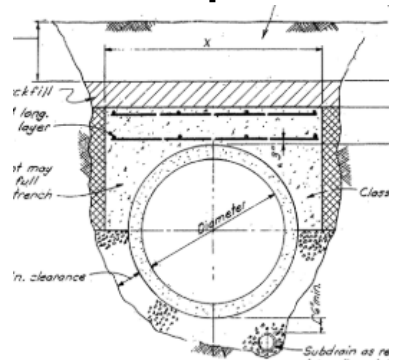
**A-3 : 2 layers #7 @ 8"**

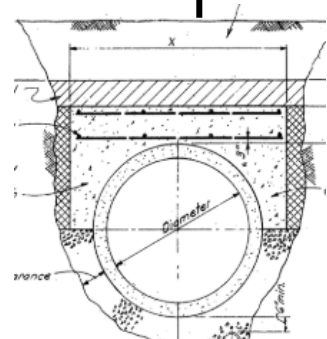
**A-1: no reinforcing**

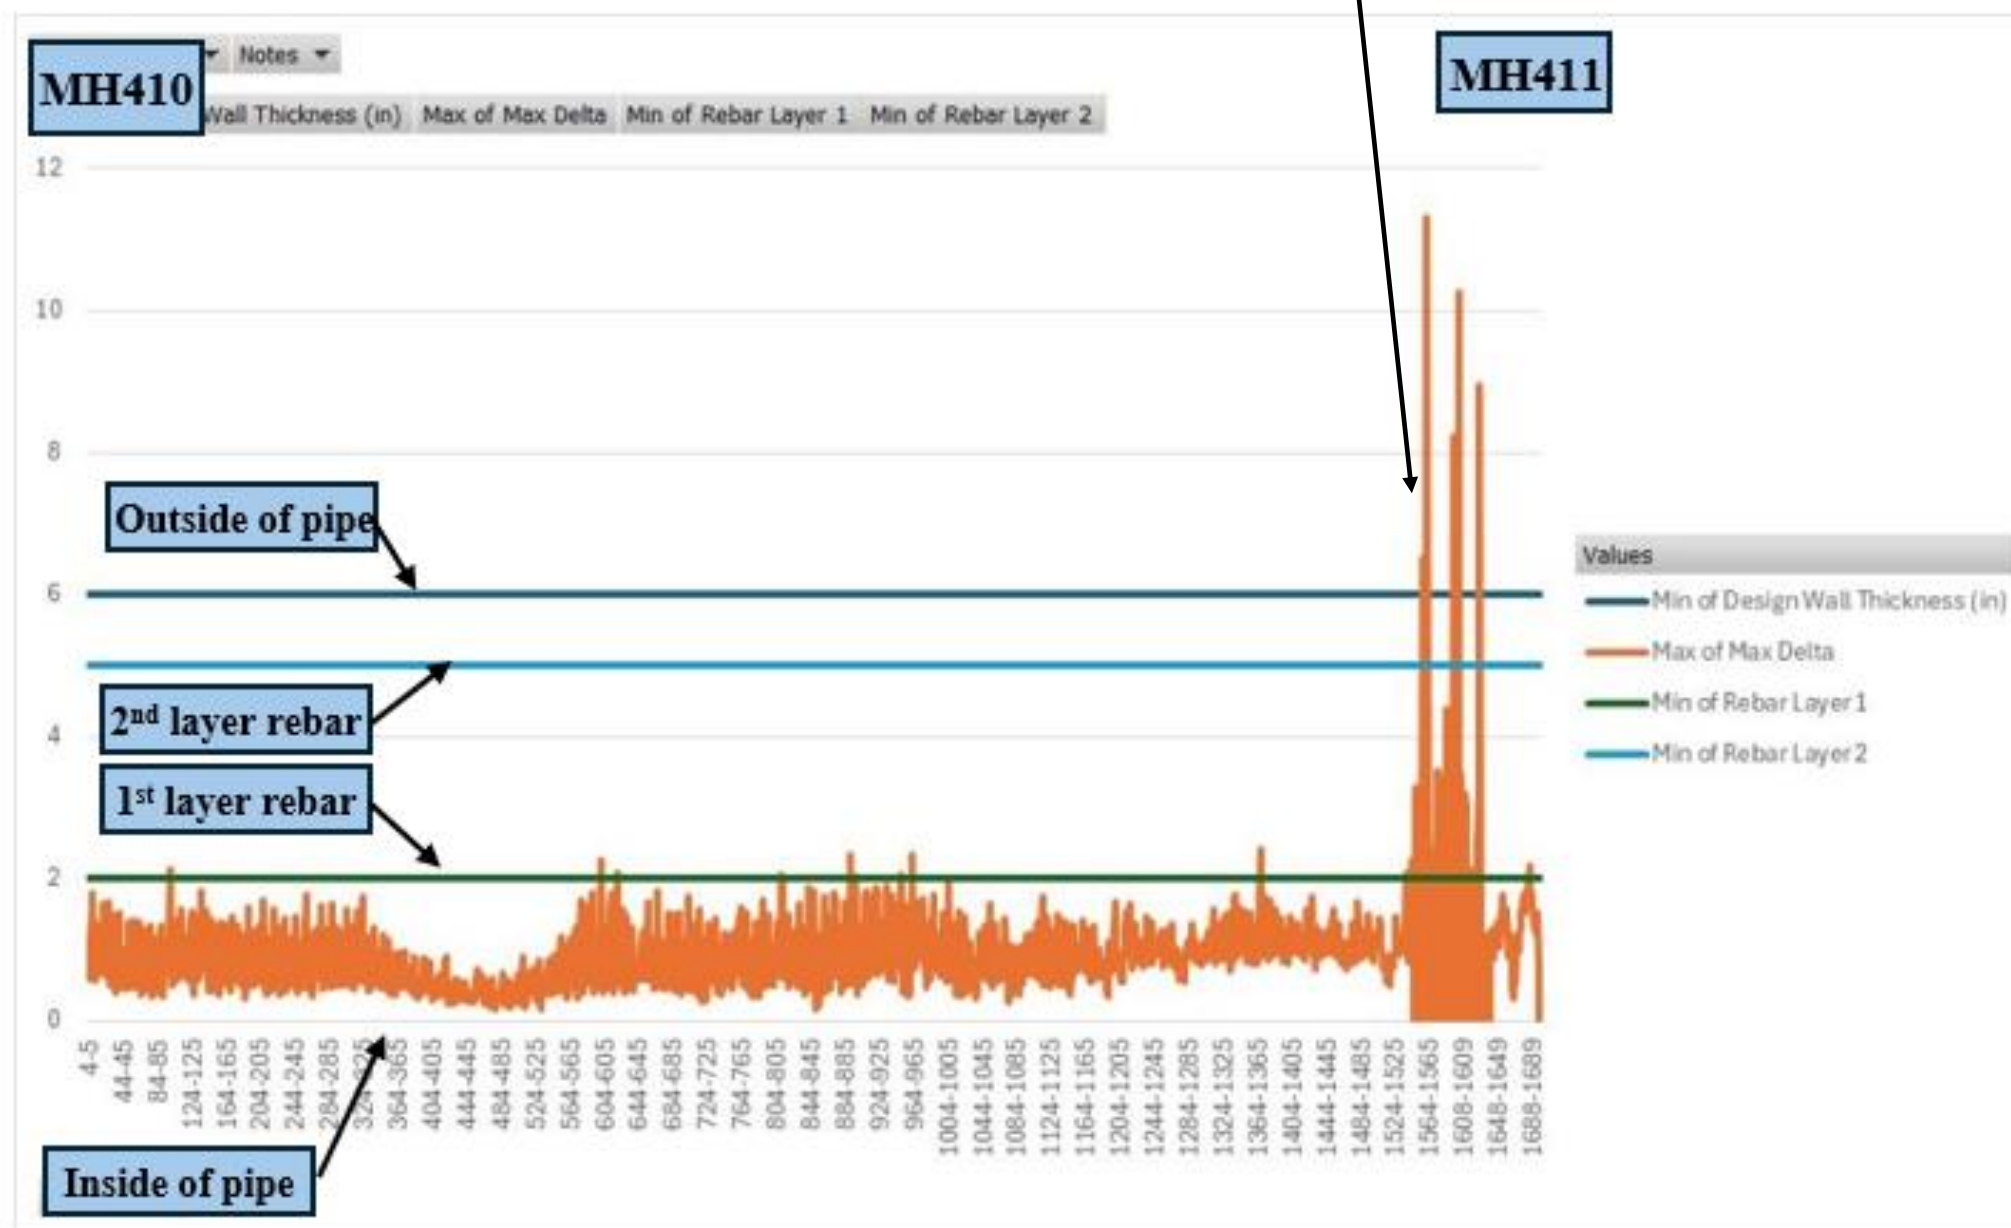
# Multi-Sensor (MSI) Inspection

MSI data is irregular due to turbulence at drop and values beyond pipe thickness are not possible. Data indicates significant wall loss consistent with CCTV.
