**DISTRICT OF COLUMBIA  
WATER AND SEWER AUTHORITY**

**Sewer Investigation:  
Bloomingdale Neighborhood**

**Final**

**October 2006**

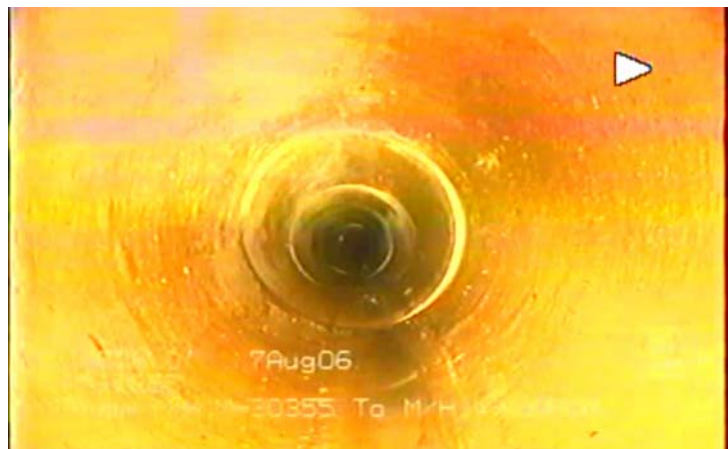
**Photo 4-1:**  
Typical Pipe Condition – Sewer  
on Thomas St

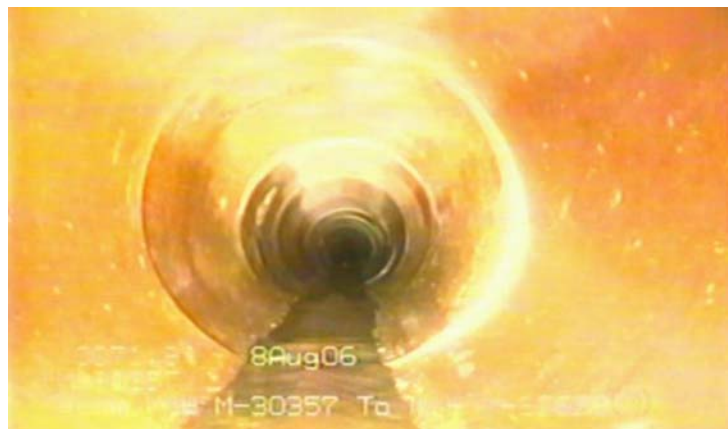
**Photo 4-2:**  
Typical Pipe Condition – Sewer  
on U-St, NW

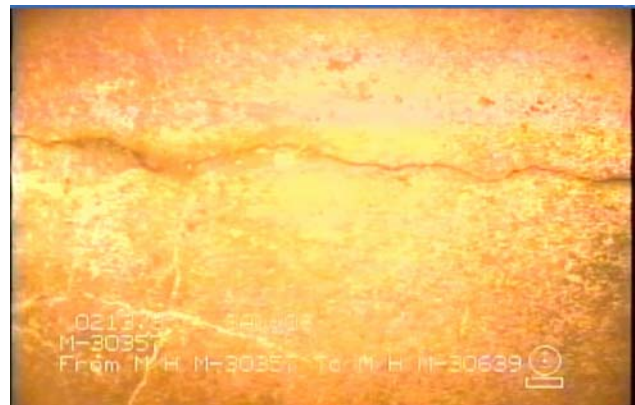
Longitudinal crack on U St sewer.  
This crack is located about 215 ft  
from M-30357.

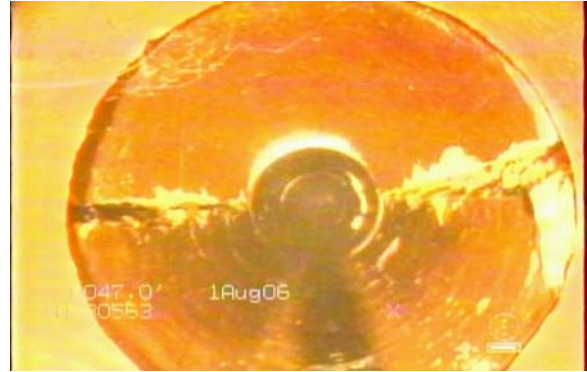
**Photo 4-4:**  
Longitudinal fracture starting  
about 47 ft from M-30563

- M-30566 to M-30568 – this combined sewer on Flagler Pl between W and V Streets was found to have an approximately 6” hole in the crown, with dirt visible. Point repair or relining this section of pipe is recommended.
- M-30563 to M-30569 - this combined sewer on Flagler Pl between W and V Streets was found to have several horizontal and circumferential cracks and some staining at the pipe joints. Point repair or relining this section of pipe is recommended. In addition, roots and soils were observed covering about 15% of the flow area at about 154 ft from M-30563. These roots need to be cut.

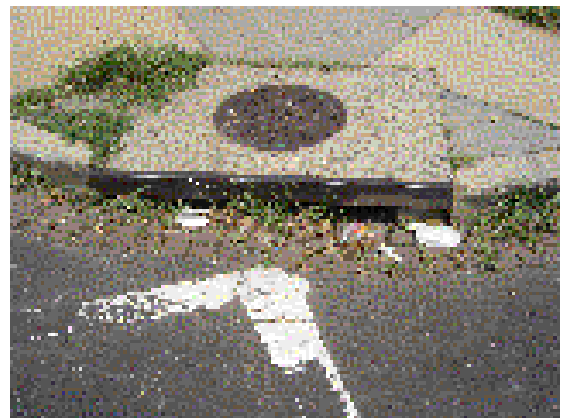
Most of the catch basin inlets are in good condition. Storm water flooding at the intersection of 2<sup>nd</sup> St and Florida Ave, however, is aggravated by damaged catch basin inlets located north of the intersection (refer photos 4-5 and 4-6). The catch basin covers and nearby curbs need to be repaired and readjusted to facilitate proper operation of the two catch basins.

**Photo: 4-5:**  
Current status of catch basin located at the  
intersection of Florida Ave and 2<sup>nd</sup> St, NW

- Construct additional inlets at the intersection of Flagler and U Street, NW
- Construct a relief sewer along Thomas Street between 1<sup>st</sup> and 2<sup>nd</sup> Street, NW
- Fix damaged catch basin inlets located at intersection of 2nd St and Florida Ave, NW.

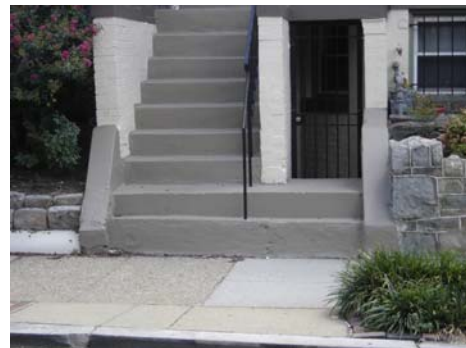
Example of extending the stairs of the main house to the basement to act as permanent barriers against floods.

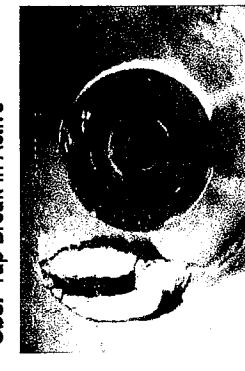
Date: 08/29/2006 Dist: 56.8 Ft  
Obs: Tap Break-in Active

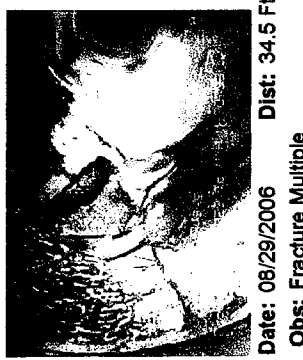
Date: 08/07/2006 Dist: 34.5 Ft  
Obs: Fracture Multiple

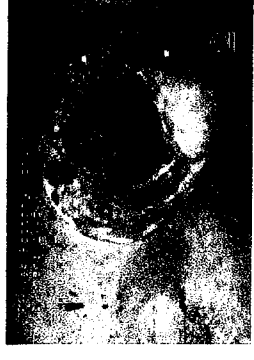
Date: 08/01/2006 Dist: 70.4 Ft  
Obs: Crack Multiple

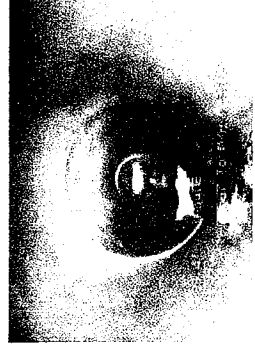
Date: 08/24/2006 Dist: 66.3 Ft  
Obs: Crack Multiple
