# Briefing on the Potomac Interceptor

DISTRICT OF COLUMBIA WATER AND SEWER AUTHORITY

# Potomac Interceptor

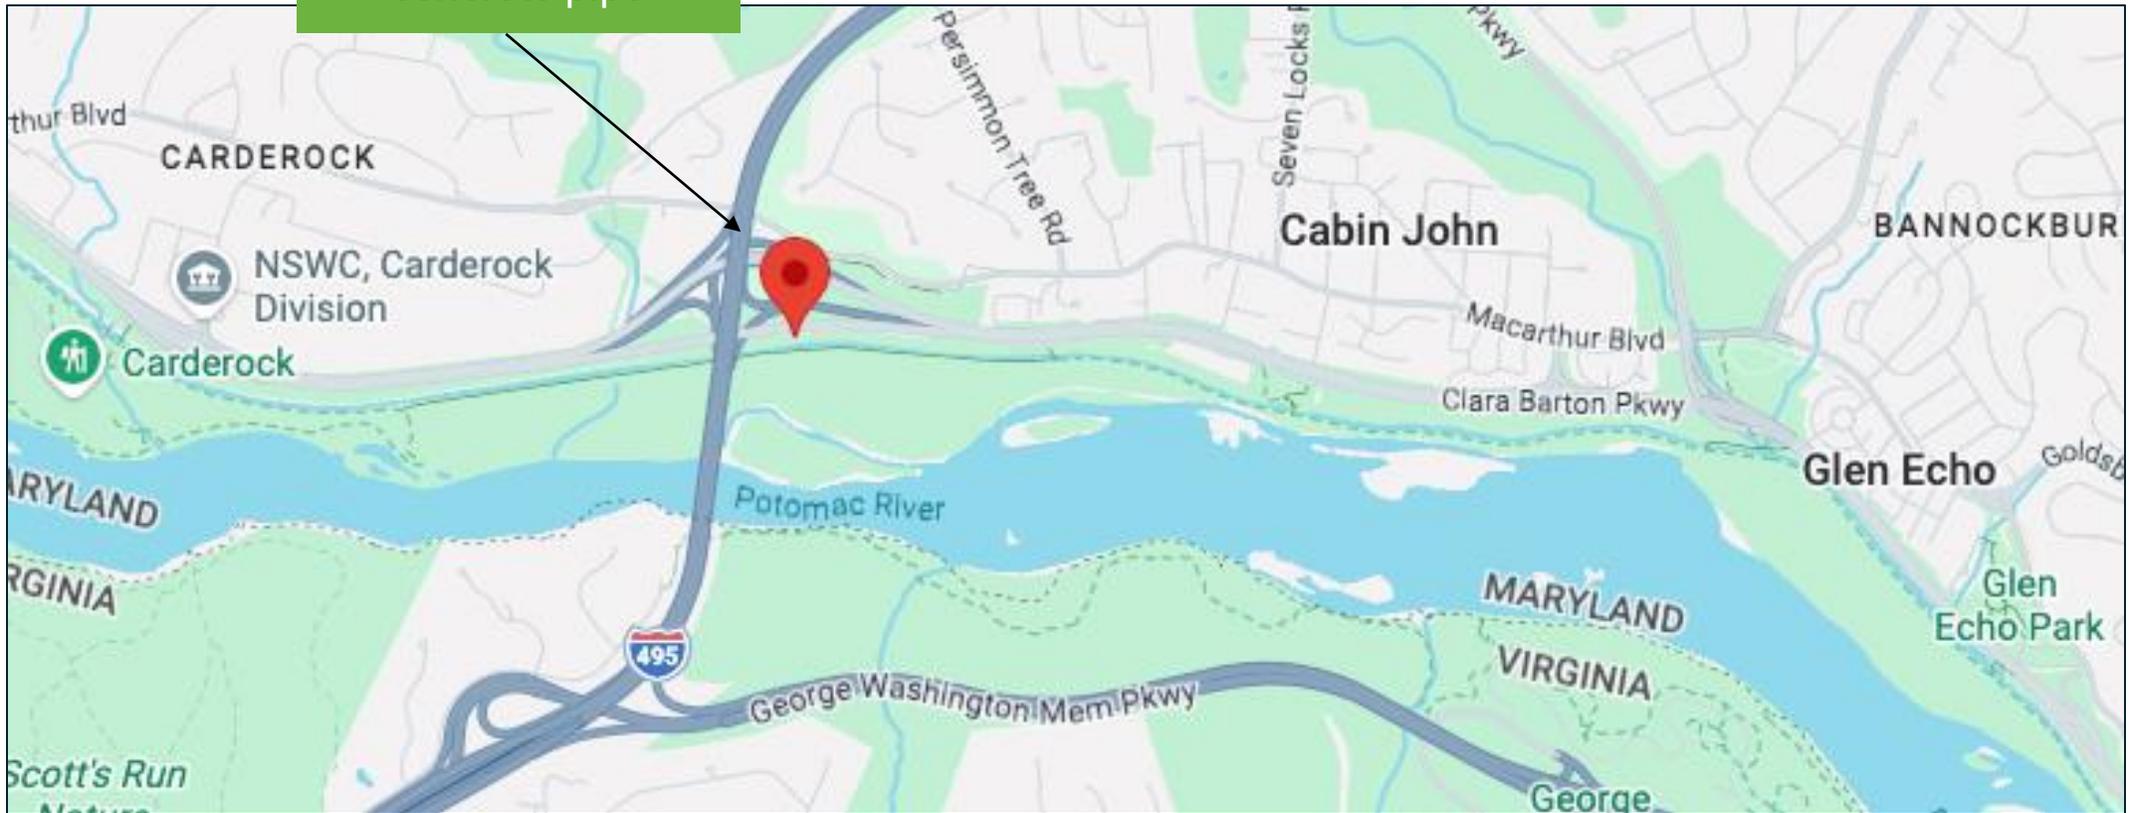
# Pipe Break

Pipe break: 72"  
diameter reinforced  
concrete pipe

STEP	ACTIVITY	TIMELINE
1	<b>Bypass Installation</b> - Install temporary bypass pumping to reroute flow through canal around damaged pipe section	Completed
2	<b>Investigation and Excavation</b> - Excavate downstream of pipe, clean and identify scope of blockage	Completed
3	<b>Repair and Flow Restoration</b> – Install bulkhead and bypass chamber; remove rock dam and repair collapsed section to restore flow	February to mid-March
4	<b>Environmental Rehabilitation</b> – Restore affected areas including drainage channel, C&O Canal and Potomac River shoreline to Swainson Island	Following repair

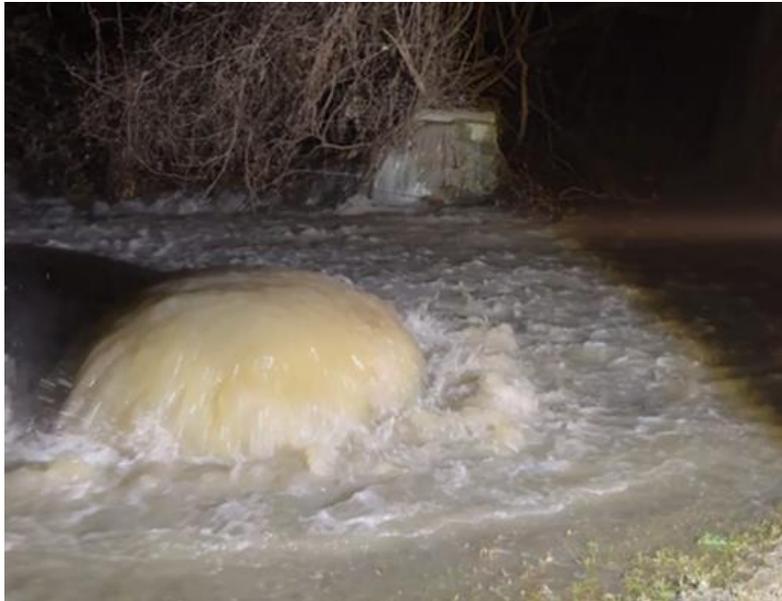
MH Upstream of Collapse

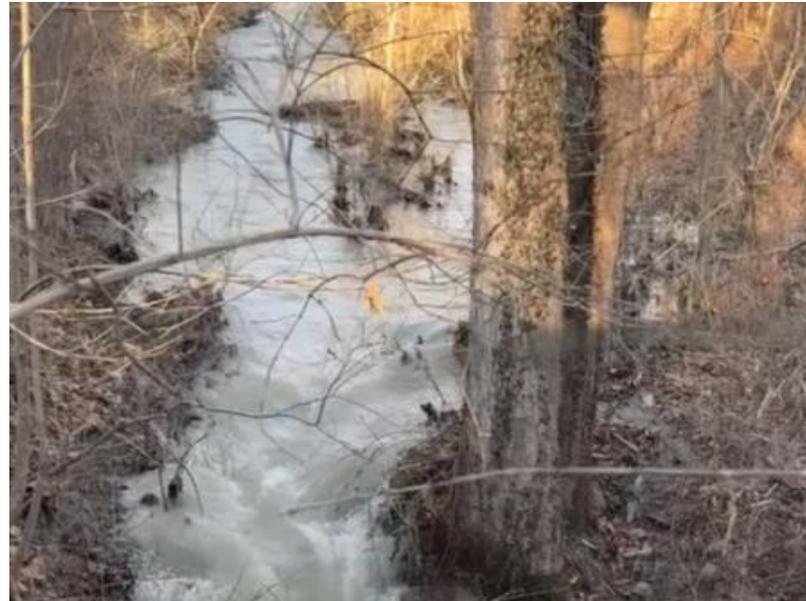
Overflow in Drainage Channel

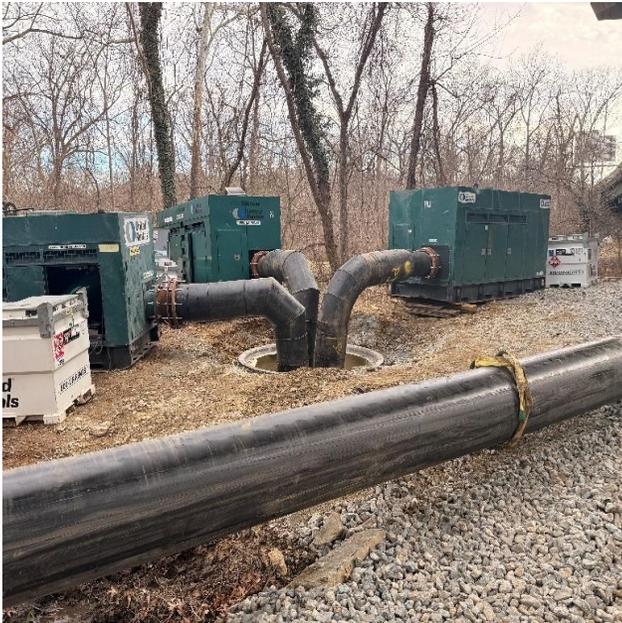
Setting Up Bypass Pumps

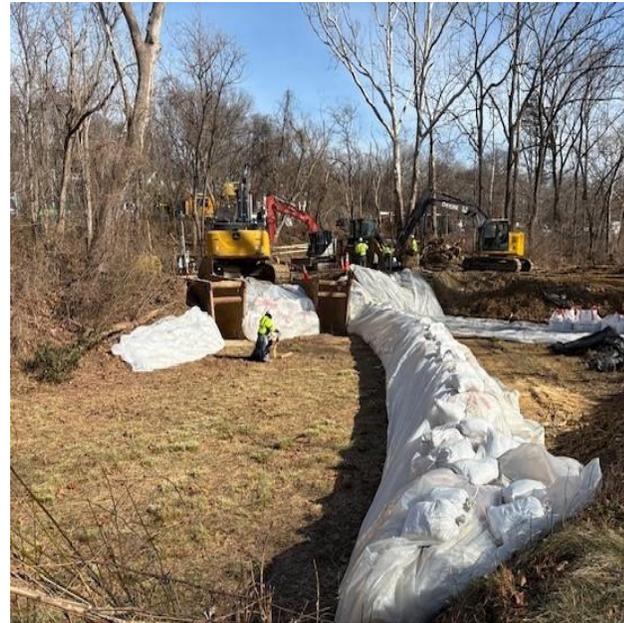
Coffer Dam in Canal

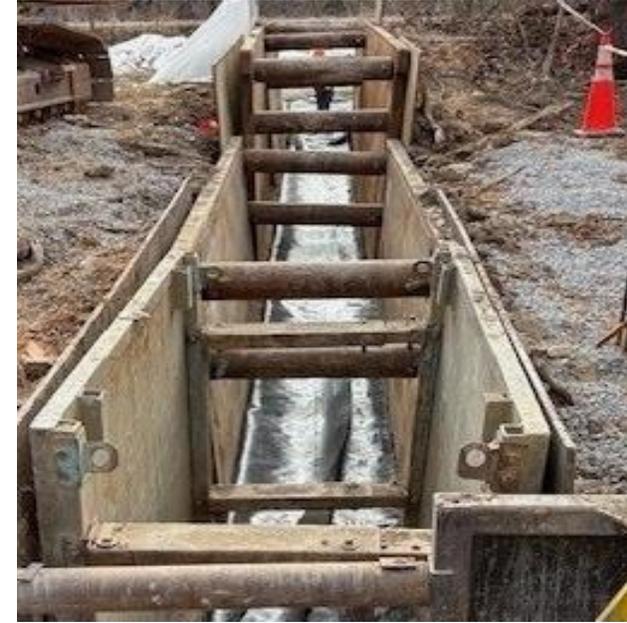
Channel Back to PI

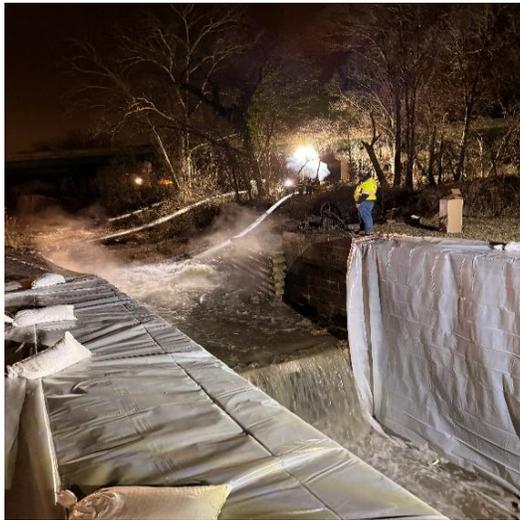
Bypass Pumping

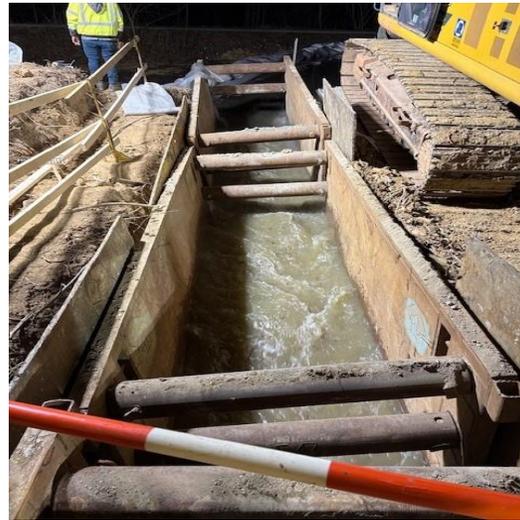
Flow in Discharge Channel

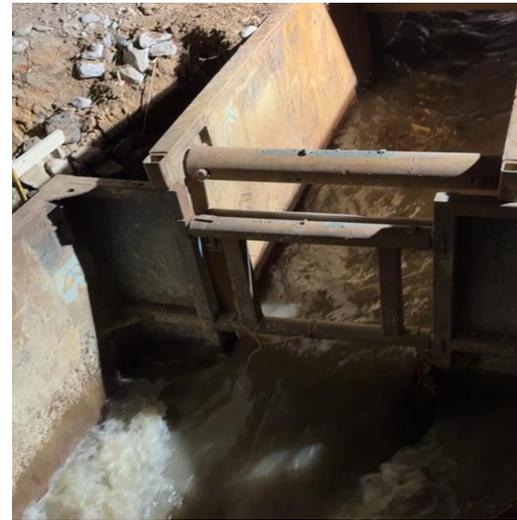
Flow Dropping Back in PI

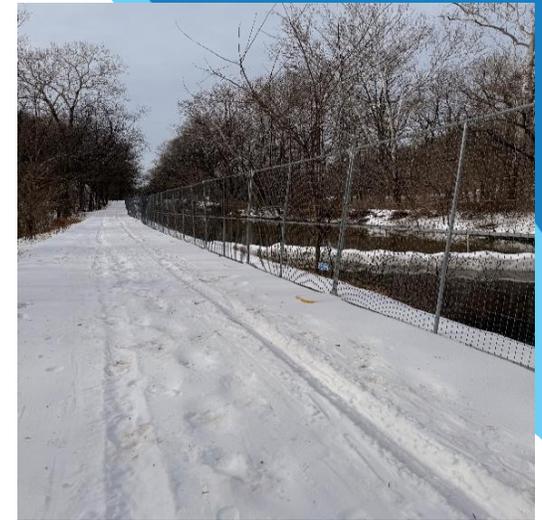
Fencing Along Canal

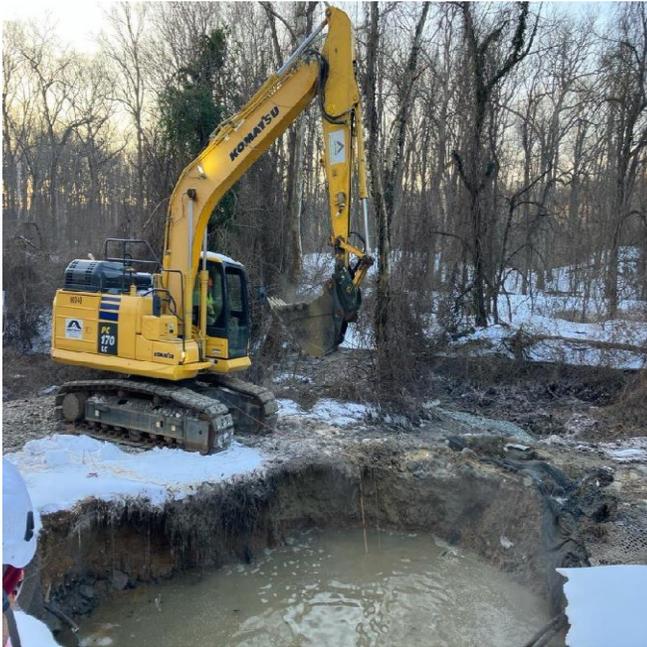
Failure Site

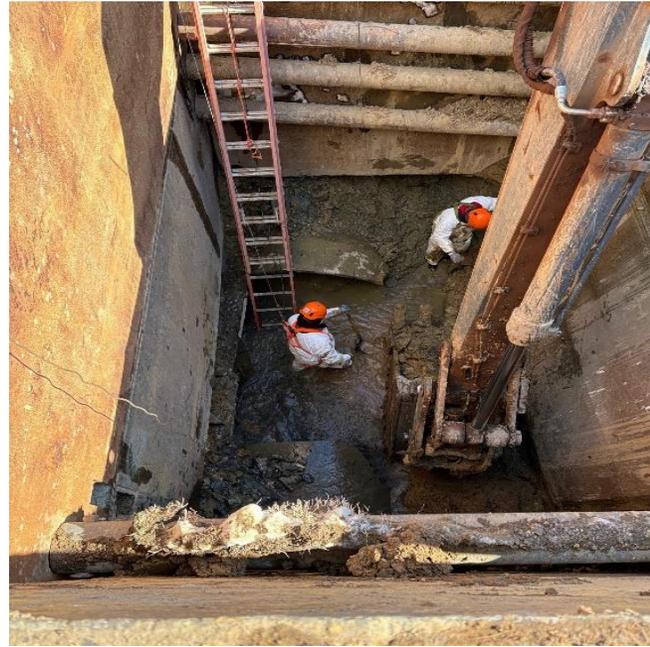
Excavation to PI

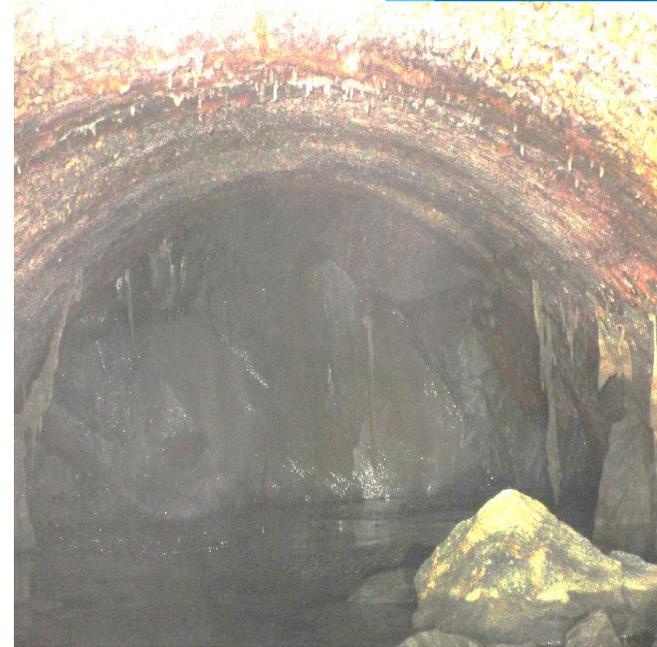
Rock Block in Failed Pipe Section

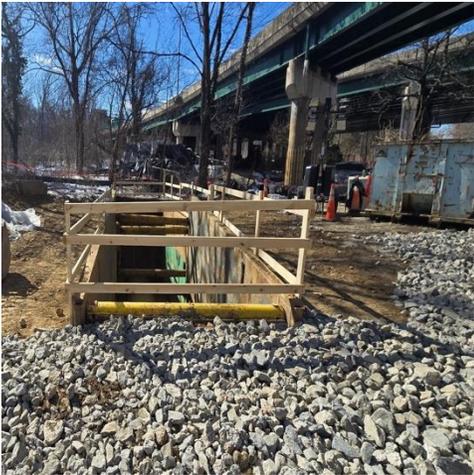
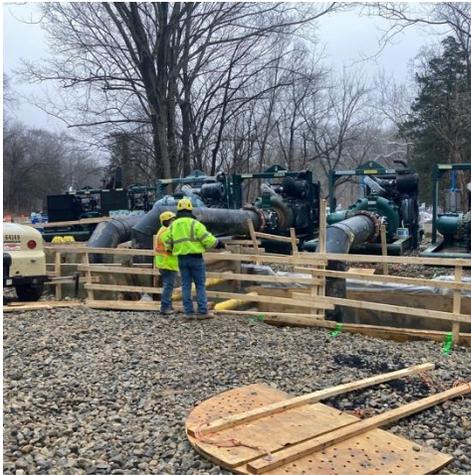
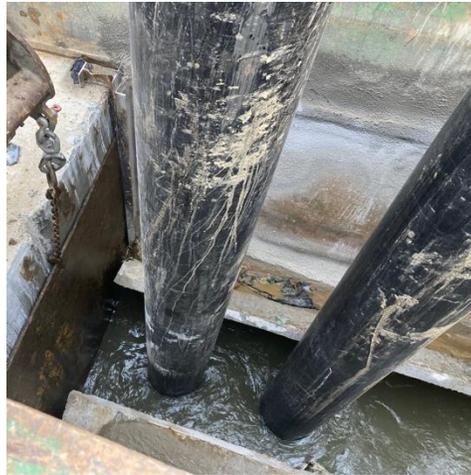
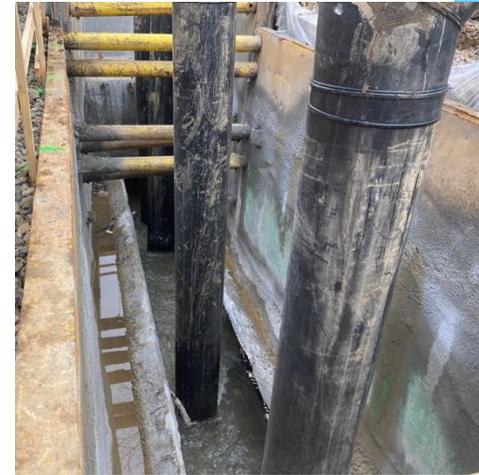
# New Chamber and Discharge Channel Under Construction

Bypass Pumping Chamber Under Construction and Made Operational
