Potomac Interceptor Collapse

Virginia DEQ Water Quality Monitoring Response

March 19, 2026

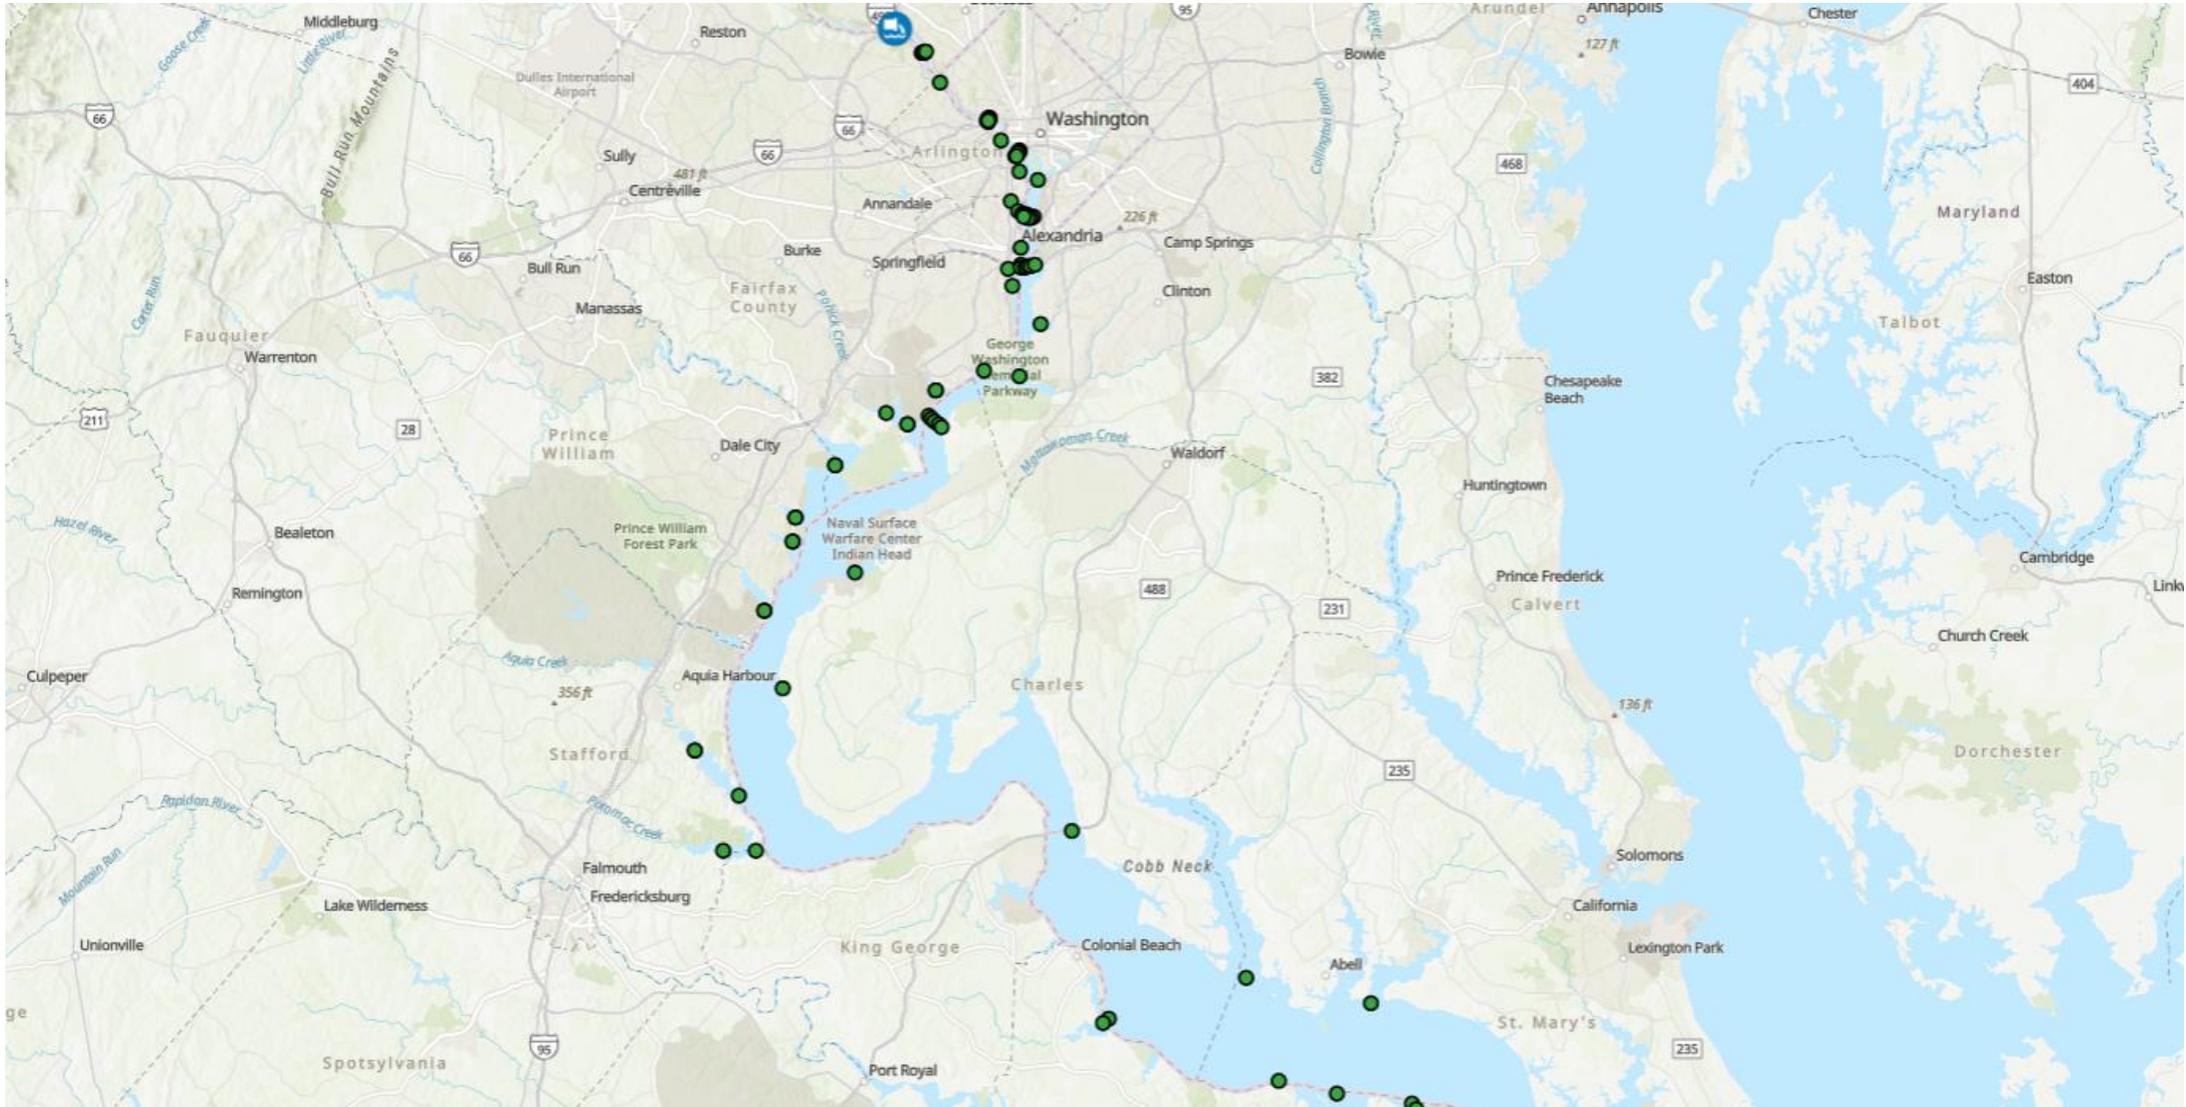
DEQ Sampling Locations

- Feb. 13** ● VDH issued recreation advisory for Virginia residents along the Potomac River
- Feb. 17** ● DEQ conducted bacteria sampling – 25 locations along ~49 miles from Chain Bridge to mouth of Potomac Creek
- Feb. 25** ● DEQ sampled 9 Virginia embayments; contractor began transect sampling at multiple locations
- Feb. 26–27** ● DEQ contractor completed transect sampling and additional surface water sampling
- Mar. 5** ● VDH partially lifted their recreation advisory - from Route 120 Chain Bridge to Harry W. Nice Memorial Bridge (US 301)
- Mar. 9** ● DEQ sampled 3 Virginia embayments (301 Bridge to Coles Point) and 3 river transects: Key Bridge, 14th St Bridge, Daingerfield Island
- Mar. 12** ● DEQ posted results from Mar. 9 – all *E. coli* results below 100 CFU/100 mL; southern embayments below detection limits (10 CFU/100 mL for *E. coli* and Enterococci)

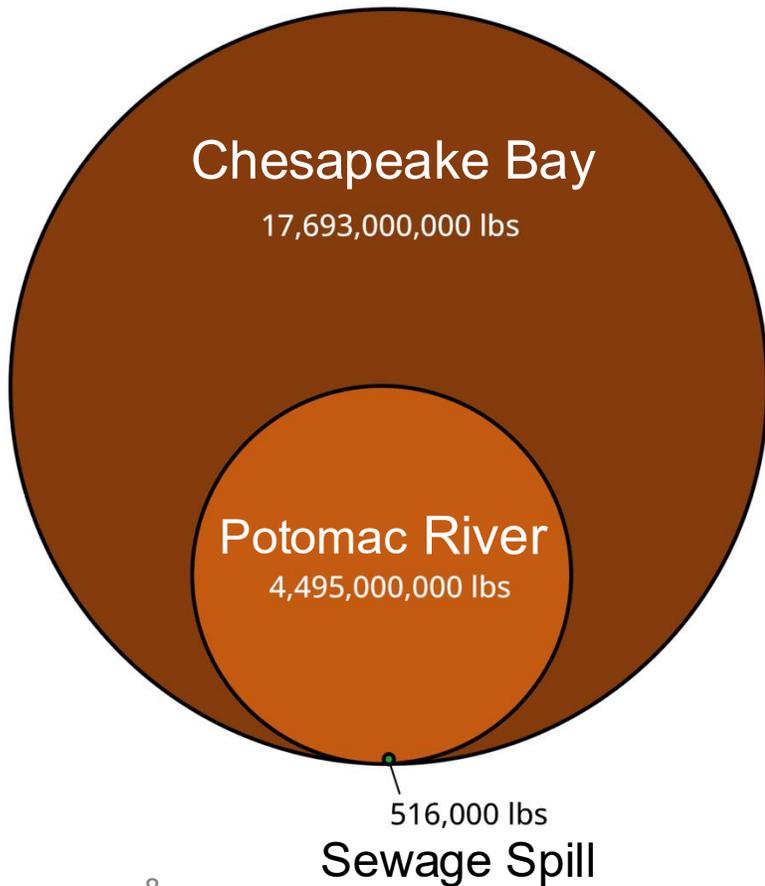
Based on 243.5 million gallons of sewage discharged, DEQ estimated pollutant loads using AlexRenew wastewater data

Nutrient & Sediment Loading Analysis (graphical)

The additional sediment and nutrient loading from the Potomac Interceptor sewage spill equates to less than ½ percent of the 2025 annual loading to the Potomac River. Bacterial modeling by ICPRB predicts return to near-background levels within ~10 days after the end of discharge.

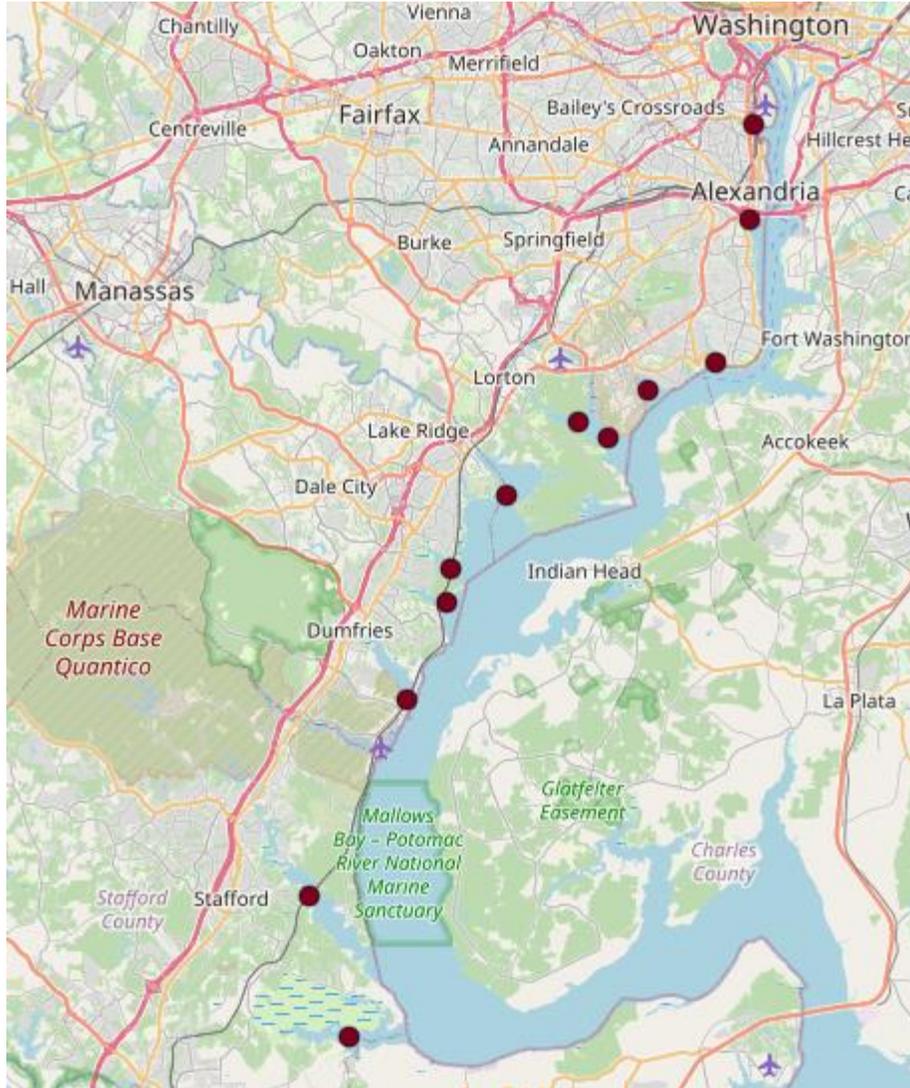
DEQ Routine Potomac River Embayment Sampling

Stream/Bay Name	Sampling Location
Four Mile Run*	G.W. PKWY Bridge
Hunting Creek*	G.W. PKWY Bridge
Little Hunting Creek*	G.W. PKWY Bridge
Dogue Creek	Across from yacht club
Pohick Creek	Across from Brick House
Pohick Creek	Off Gunston Hall
Occoquan River (Belmont Bay)	Near red daymarker #5
Neabsco Creek	Railroad (RR) bridge
Powells Creek	100 yds up from RR bridge
Quantico Creek	100 yds up from RR bridge
Aquia Creek	Downstream of RR bridge
Potomac Creek	Downstream of RR bridge
