Potomac Interceptor

INSPECTION REPORTS

DISTRICT OF COLUMBIA WATER AND SEWER AUTHORITY

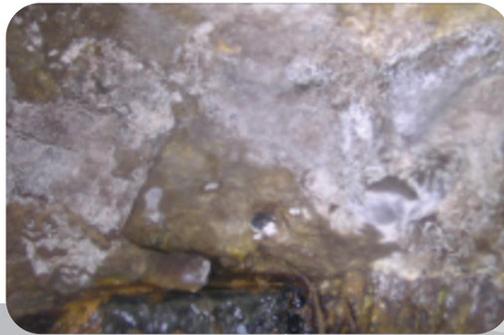
157.4' – “Hole Void Visible,”
Structural Grade 5
incorrect; do not
see hole in video.
(It’s concrete)

In June 2024, this defect was identified as “infiltration gusher” with structural grade of 0. In October 2024, this defect was identified as “hole void visible” with structural grade of 5.

shows that this defect was misidentified and the dark area at approximately the 9 o'clock position is concrete pipe. This is supported by the following:

- As shown by the other infiltration weepers in the video, the pipe is subject to infiltration by groundwater. If the discolored area were soil, one would expect to see infiltration into the pipe at this location, which is not present in the video.

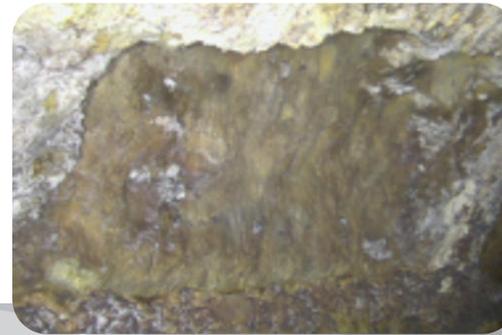
162' – “Hole Soil Visible,” Structural
Grade 5 incorrect;
do not see soil in
video. (It’s concrete)

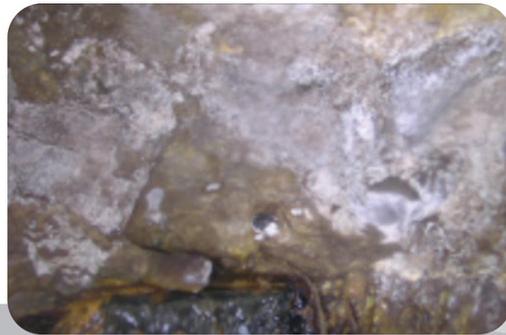
157.4' – "Hole Void Visible,"
Structural Grade 5 incorrect; do not
see hole in video.
(It's concrete)

CCTV: 157.4' – “Hole Void Visible,” Structural Grade 5 Incorrect, Do Not See Hole in Video

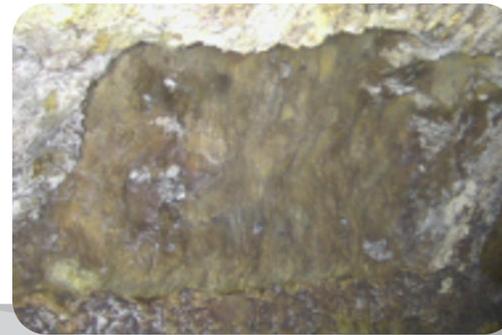
162' – "Hole Soil Visible," Structural
Grade 5 incorrect;
do not see soil in
video. (It's concrete)

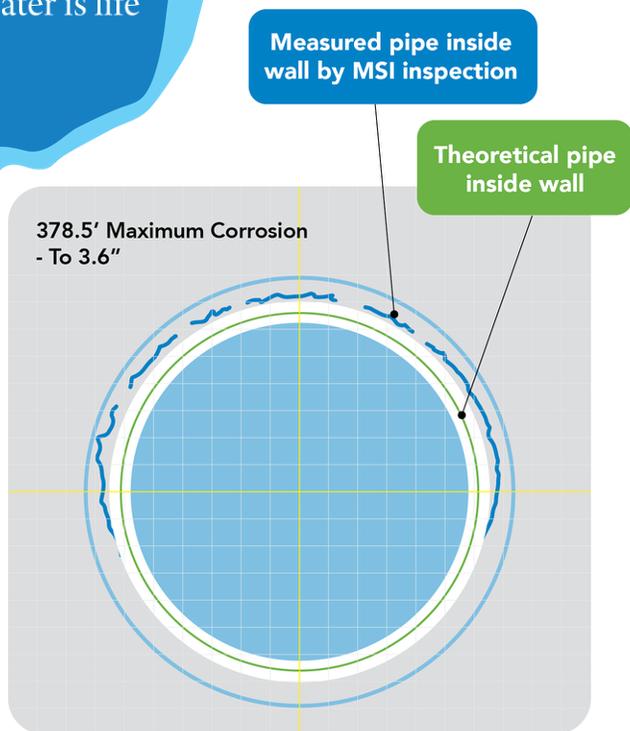
Laser / Sonar Inspection

DATE	MSI RESULTS MH16 TO MH17
2021	<ul style="list-style-type: none"> • Not performed • Upstream section was performed
June 2024	<ul style="list-style-type: none"> • Inspection rejected due to poor quality/splashing • No data 0' to 237' (in break zone) • Up to 5.7" corrosion at 237.5' (break occurred at 168' to 184') • Up to 5.6" corrosion at 292.9' (break occurred at 168' to 184')
October 2024	<ul style="list-style-type: none"> • No data 0' to 378.5' due to flow conditions (in break zone) • Up to 3.6" corrosion at 378.5' (break occurred at 168' to 184')

- Laser above water level/sonar below water level
- Called "Multi Sensor Inspection" or MSI

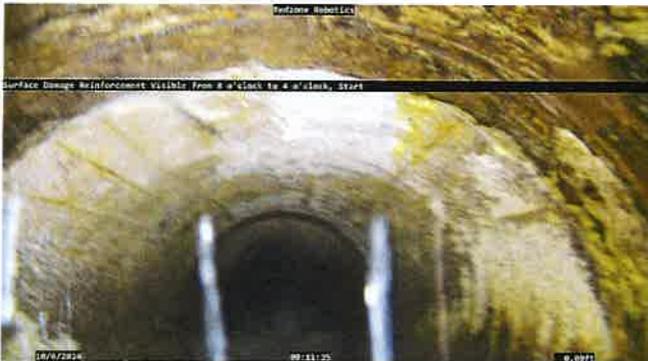
Code: **SRV**
 Description: **Surface Damage Reinforcement Visible**

Distance (ft): **.0**
 Structural Grade: **4**
 O&M Grade: **0**
 Clock Start/From: **8**
 Clock To: **4**
 1st Value:
 2nd Value:
 Value Percent:
 Continuous Index: **S01**
 Within 8" of Joint: **NO**
 Remarks:

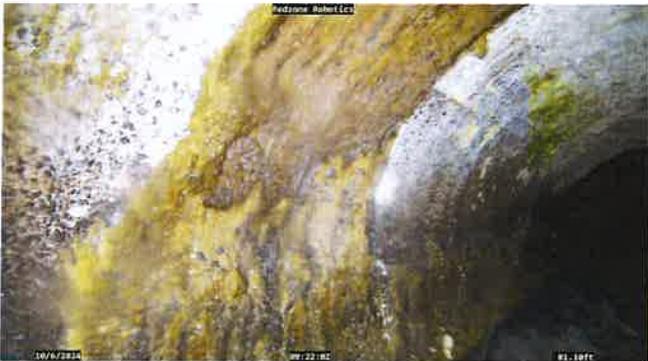
Code: **IW**
 Description: **Infiltration Weeper**

Distance (ft): **81.1**
 Structural Grade: **0**
 O&M Grade: **2**
 Clock Start/From: **8**
 Clock To: **4**
 1st Value:
 2nd Value:
 Value Percent:
 Continuous Index:
 Within 8" of Joint: **NO**

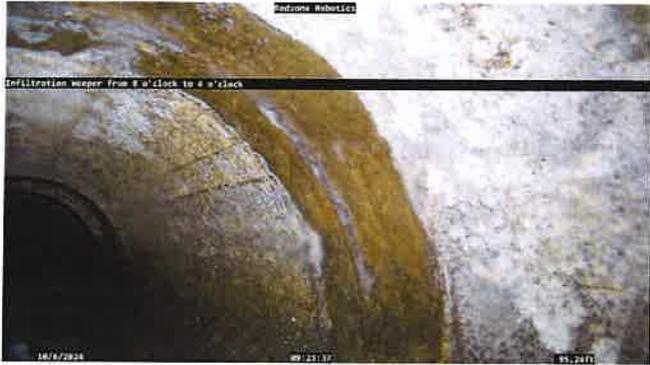
Code: **IW**
 Description: **Infiltration Weeper**

Distance (ft): **95.2**
 Structural Grade: **0**
 O&M Grade: **2**
 Clock Start/From: **8**
 Clock To: **4**
 1st Value:
 2nd Value:
 Value Percent:
 Continuous Index:
 Within 8" of Joint: **NO**
 Remarks:

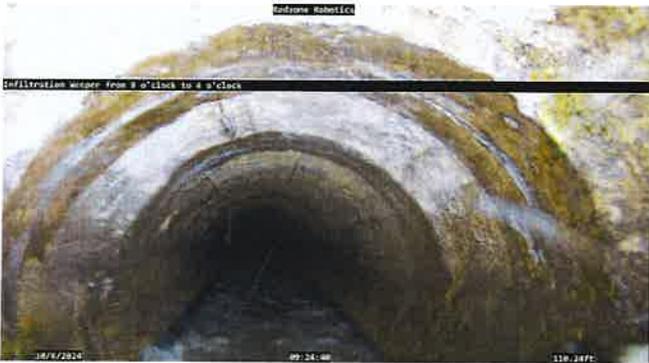
Code: **IW**
 Description: **Infiltration Weeper**

Distance (ft): **110.2**
 Structural Grade: **0**
 O&M Grade: **2**
 Clock Start/From: **8**
 Clock To: **4**
 1st Value:
 2nd Value:
 Value Percent:
 Continuous Index:
 Within 8" of Joint: **NO**
 Remarks:

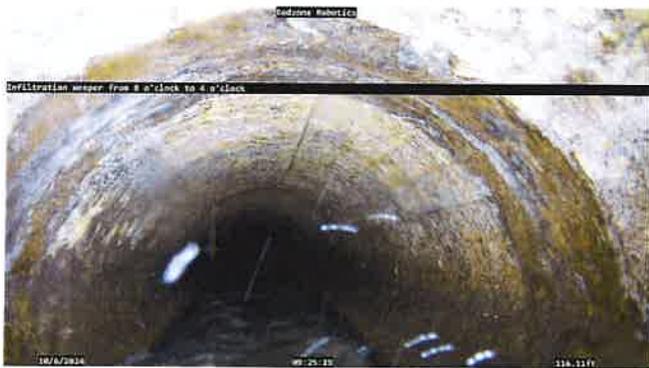
Code: **IW**
 Description: **Infiltration Weeper**

Distance (ft): **116.1**
 Structural Grade: **0**
 O&M Grade: **2**
 Clock Start/From: **8**
 Clock To: **4**
 1st Value:
 2nd Value:
 Value Percent:
 Continuous Index:
 Within 8" of Joint: **NO**
 Remarks:

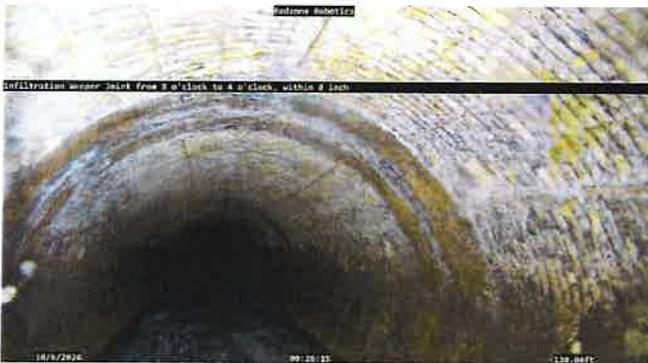
Code: **IWJ**
 Description: **Infiltration Weeper Joint**

Distance (ft): **130.0**
 Structural Grade: **0**
 O&M Grade: **2**
 Clock Start/From: **8**
 Clock To: **4**
 1st Value:
 2nd Value:
 Value Percent:
 Continuous Index:
 Within 8" of Joint: **YES**
 Remarks:

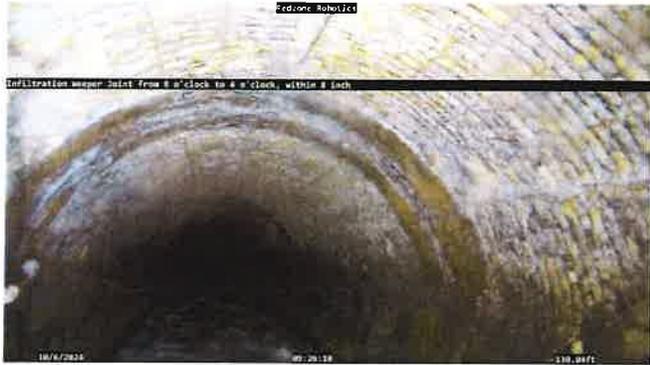
Code: **SRP**
 Description: **Surface Damage Reinforcement Projecting**

Distance (ft): **130.0**
 Structural Grade: **5**
 O&M Grade: **0**
 Clock Start/From: **2**
 Clock To:
 1st Value:
 2nd Value:
 Value Percent:
 Continuous Index:
 Within 8" of Joint: **YES**
 Remarks: **hanging**

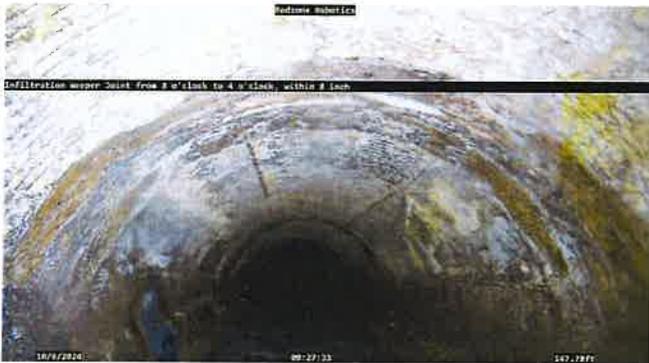
Code: **IWJ**
 Description: **Infiltration Weeper Joint**

Distance (ft): **147.8**
 Structural Grade: **0**
 O&M Grade: **2**
 Clock Start/From: **8**
 Clock To: **4**
 1st Value:
 2nd Value:
 Value Percent:
 Continuous Index:
 Within 8" of Joint: **YES**
 Remarks:

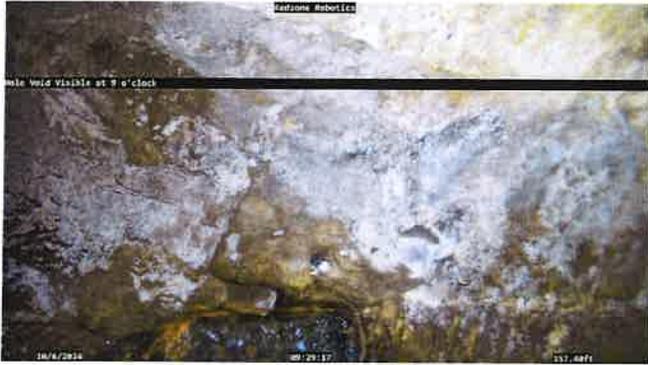
- October 6, 2024
 - Report contents:
 - 147.8', 164.6' and 195.6' - infiltration weepers, each with O&M ratings of 2.
 - 157.4' – this defect was an infiltration runner with an O&M grade of 4 that was also scored as a hole with a structural grade of 5. Based on review of the video, this is the same defect identified in the June 2024 report at 156.9' and the size and shape look similar to the June 2024 inspection. The infiltration observation is correct, but the 'hole void visible' assertion appears to be a misidentification. There is dark colored concrete above and around the infiltration area. This area has the surface texture of concrete, gray areas indicative of concrete, and has a tapered zone around the perimeter showing the transition in concrete thickness. This area is located between 10' and 26' upstream of the break area.

Code: **HVV**
Description: **Hole Void Visible**

Distance (ft): **157.4**
Structural Grade: **5**
O&M Grade: **0**
Clock Start/From: **9**
Clock To:
1st Value:
2nd Value:
Value Percent:
Continuous Index:
Within 8" of Joint: **NO**
Remarks:

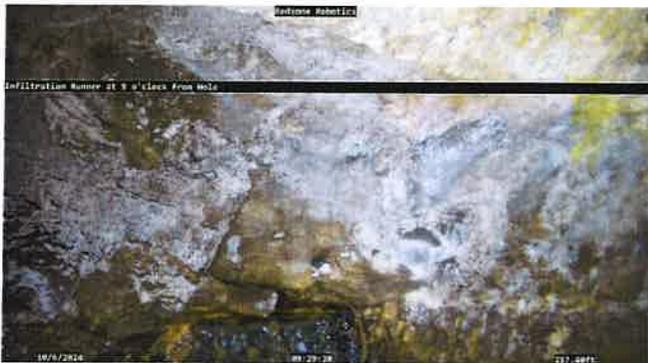
Code: **IR**
Description: **Infiltration Runner**

Distance (ft): **157.4**
Structural Grade: **0**
O&M Grade: **4**
Clock Start/From: **9**
Clock To:
1st Value:
2nd Value:
Value Percent:
Continuous Index:
Within 8" of Joint: **NO**
Remarks: **From Hole**

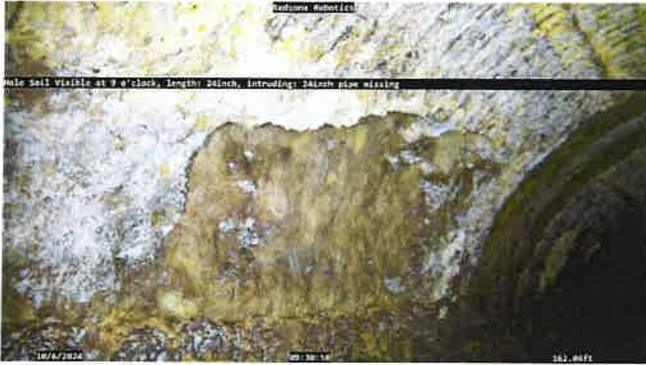
Code: **HSV**
 Description: **Hole Soil Visible**

Distance (ft): **162.0**
 Structural Grade: **5**
 O&M Grade: **0**
 Clock Start/From: **9**
 Clock To:
 1st Value: **24.000**
 2nd Value: **24.000**
 Value Percent:
 Continuous Index:
 Within 8" of Joint: **NO**
 Remarks: **pipe missing**

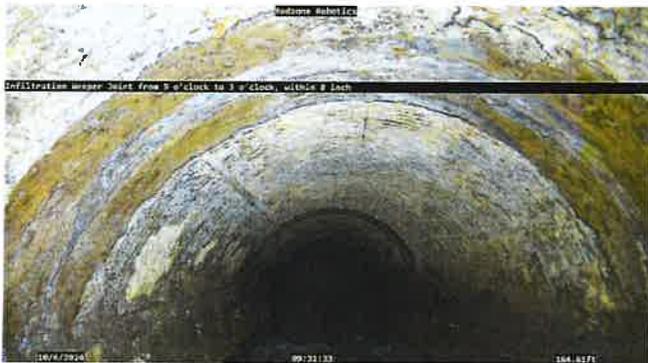
Code: **IWJ**
 Description: **Infiltration Weeper Joint**

Distance (ft): **164.6**
 Structural Grade: **0**
 O&M Grade: **2**
 Clock Start/From: **9**
 Clock To: **3**
 1st Value:
 2nd Value:
 Value Percent:
 Continuous Index:
 Within 8" of Joint: **YES**
 Remarks:

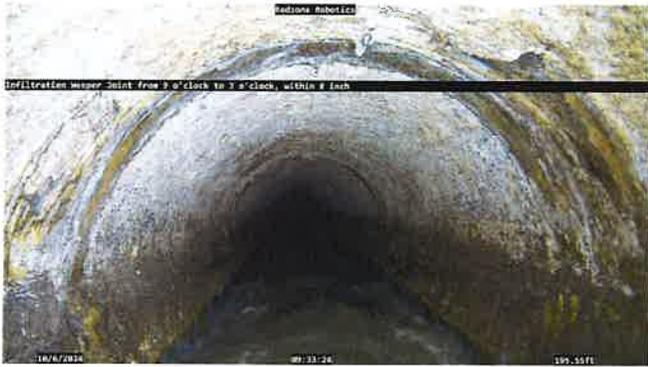
Code: **IWJ**
 Description: **Infiltration Weeper Joint**

Distance (ft): **195.6**
 Structural Grade: **0**
 O&M Grade: **2**
 Clock Start/From: **9**
 Clock To: **3**
 1st Value:
 2nd Value:
 Value Percent:
 Continuous Index:
 Within 8" of Joint: **YES**
 Remarks:

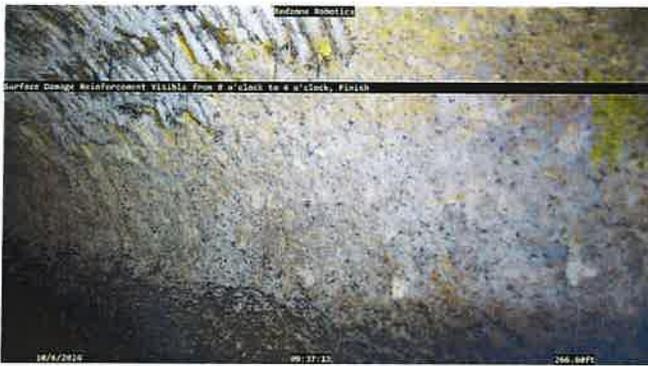
Code: **SRV**
 Description: **Surface Damage Reinforcement Visible**

Distance (ft): **266.6**
 Structural Grade: **4**
 O&M Grade: **0**
 Clock Start/From: **8**
 Clock To: **4**
 1st Value:
 2nd Value:
 Value Percent:
 Continuous Index: **F01**
 Within 8" of Joint: **NO**
 Remarks:

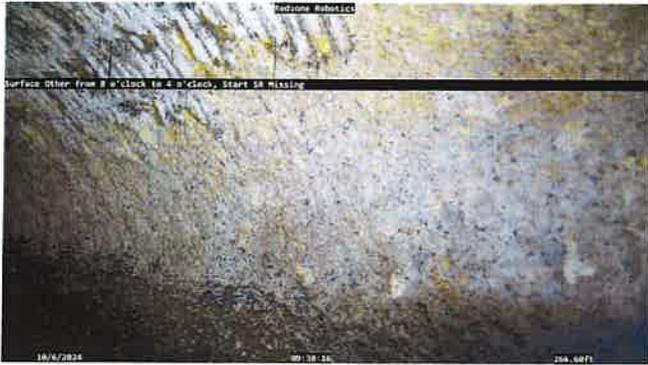
Code: **SZ**
 Description: **Surface Damage Other**

Distance (ft): **266.6**
 Structural Grade: **0**
 O&M Grade: **0**
 Clock Start/From: **8**
 Clock To: **4**
 1st Value:
 2nd Value:
 Value Percent:
 Continuous Index: **S02**
 Within 8" of Joint: **NO**
 Remarks: **SR Missing**

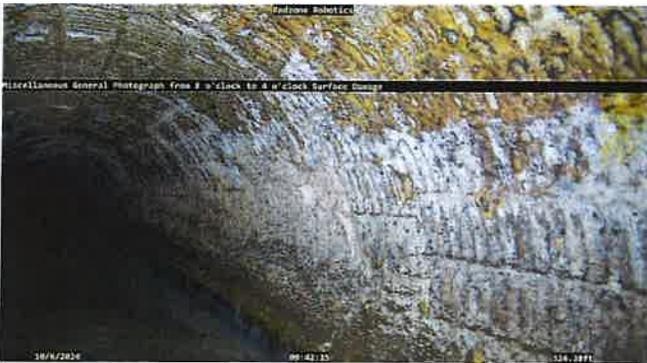
Code: **MGP**
 Description: **Miscellaneous General Photograph**

Distance (ft): **324.4**
 Structural Grade: **0**
 O&M Grade: **0**
 Clock Start/From: **8**
 Clock To: **4**
 1st Value:
 2nd Value:
 Value Percent:
 Continuous Index:
 Within 8" of Joint: **NO**
 Remarks: **Surface Damage**

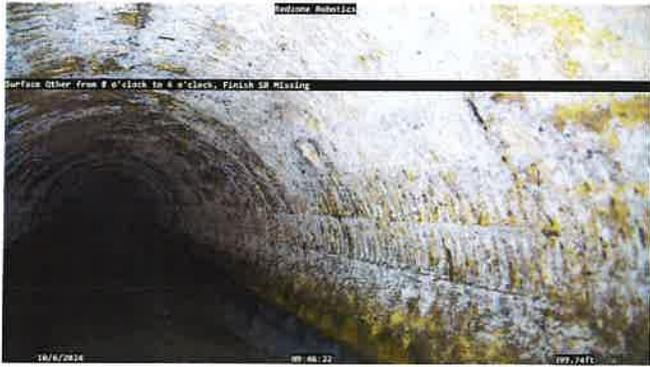
Code: **SZ**
 Description: **Surface Damage Other**

Distance (ft): **399.7**
 Structural Grade: **0**
 O&M Grade: **0**
 Clock Start/From: **8**
 Clock To: **4**
 1st Value:
 2nd Value:
 Value Percent:
 Continuous Index: **F02**
 Within 8" of Joint: **NO**
 Remarks: **SR Missing**

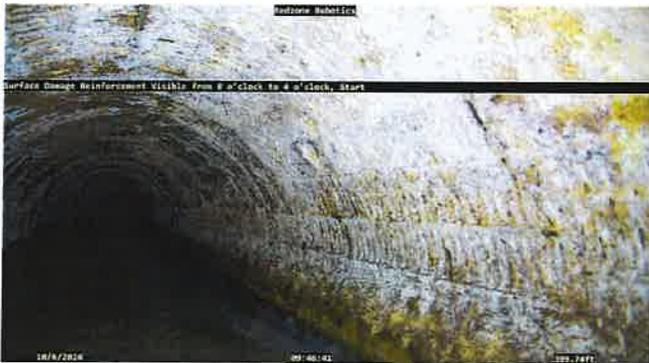
Code: **SRV**
 Description: **Surface Damage Reinforcement Visible**

Distance (ft): **399.7**
 Structural Grade: **4**
 O&M Grade: **0**
 Clock Start/From: **8**
 Clock To: **4**
 1st Value:
 2nd Value:
 Value Percent:
 Continuous Index: **S03**
 Within 8" of Joint: **NO**
 Remarks:

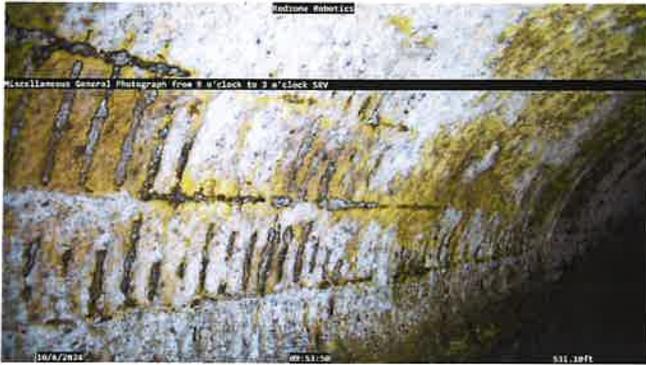
Code: **MGP**
 Description: **Miscellaneous General Photograph**

Distance (ft): **531.1**
 Structural Grade: **0**
 O&M Grade: **0**
 Clock Start/From: **9**
 Clock To: **3**
 1st Value:
 2nd Value:
 Value Percent:
 Continuous Index:
 Within 8" of Joint: **NO**
 Remarks: **SRV**

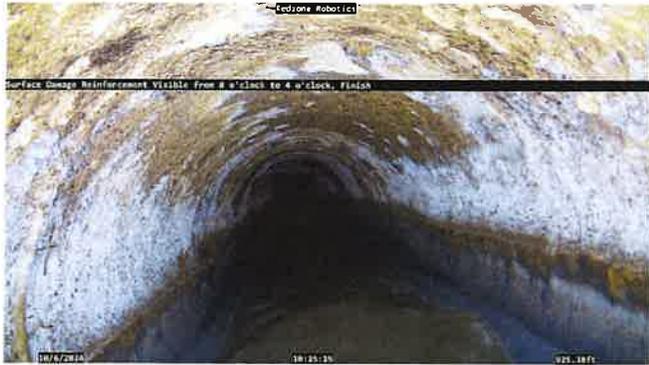
Code: **SAV**
 Description: **Surface Damage Aggregate Visible**

Distance (ft): **925.4**
 Structural Grade: **2**
 O&M Grade: **0**
 Clock Start/From: **8**
 Clock To: **4**
 1st Value:
 2nd Value:
 Value Percent:
 Continuous Index: **S04**
 Within 8" of Joint: **NO**
 Remarks:

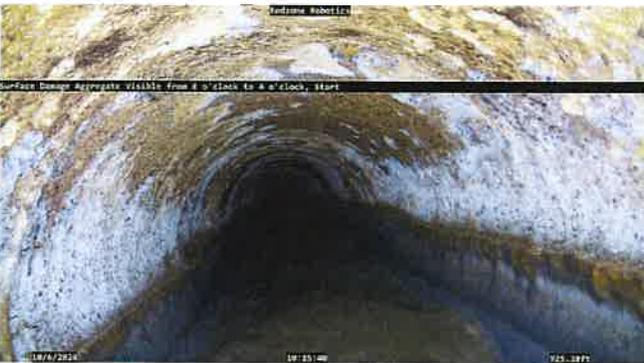
Code: **SAV**
 Description: **Surface Damage Aggregate Visible**

Distance (ft): **943.5**
 Structural Grade: **2**
 O&M Grade: **0**
 Clock Start/From: **8**
 Clock To: **4**
 1st Value:
 2nd Value:
 Value Percent:
 Continuous Index: **F04**
 Within 8" of Joint: **NO**
 Remarks:

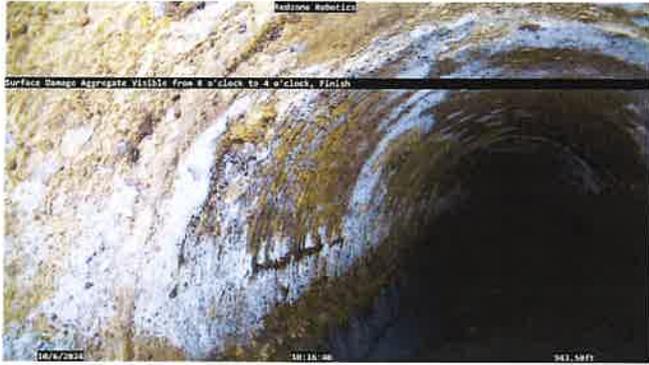
Code: **SRV**
 Description: **Surface Damage Reinforcement Visible**

Distance (ft): **943.5**
 Structural Grade: **4**
 O&M Grade: **0**
 Clock Start/From: **8**
 Clock To: **4**
 1st Value:
 2nd Value:
 Value Percent:
 Continuous Index: **S05**
 Within 8" of Joint: **NO**
 Remarks:

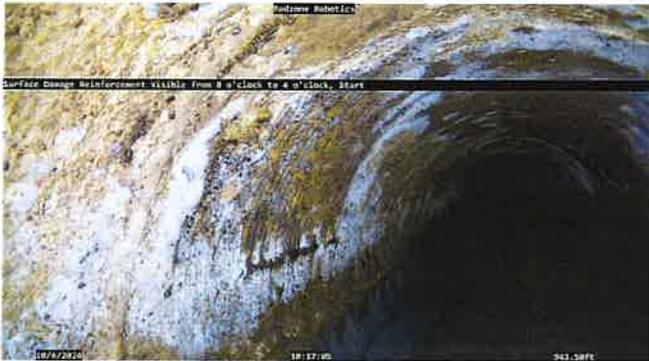
Code: **SRV**
 Description: **Surface Damage Reinforcement Visible**

Distance (ft): **994.7**
 Structural Grade: **4**
 O&M Grade: **0**
 Clock Start/From: **8**
 Clock To: **4**
 1st Value:
 2nd Value:
 Value Percent:
 Continuous Index: **F05**
 Within 8" of Joint: **NO**
 Remarks:

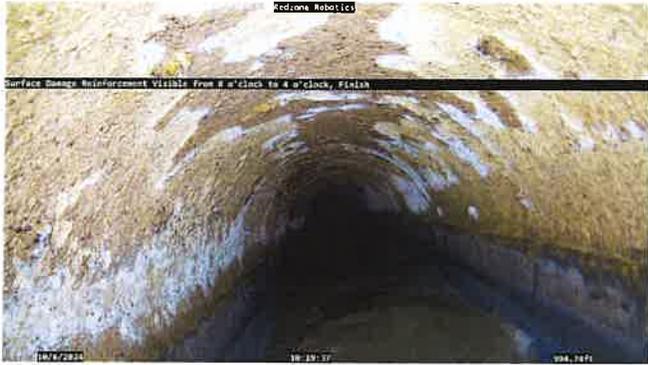
Code: **SAV**
 Description: **Surface Damage Aggregate Visible**

Distance (ft): **994.7**
 Structural Grade: **2**
 O&M Grade: **0**
 Clock Start/From: **8**
 Clock To: **4**
 1st Value:
 2nd Value:
 Value Percent:
 Continuous Index: **S06**
 Within 8" of Joint: **NO**
 Remarks:

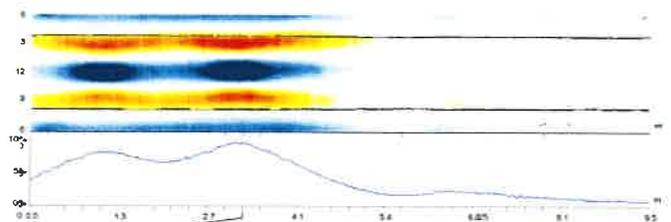
4.6m - Maximum Corrosion - To 67mm

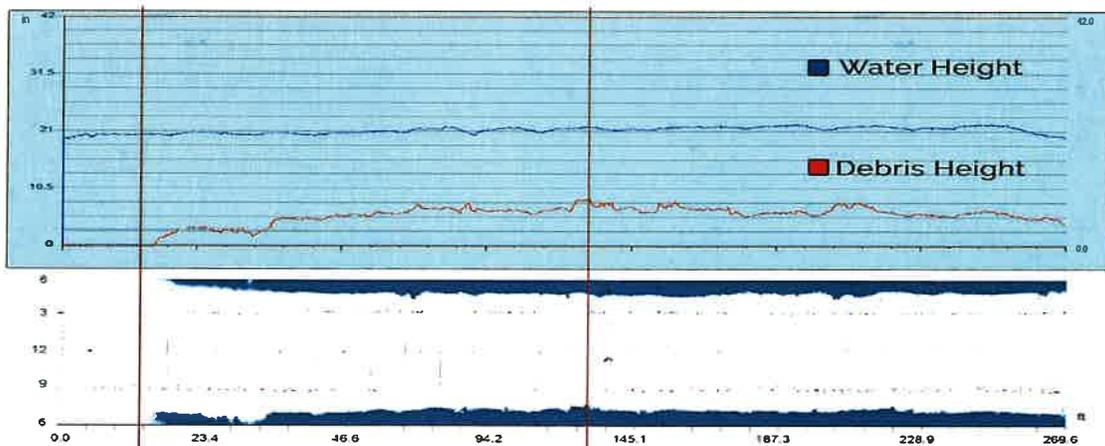
10.6ft 3D Observation - 3D Laser-Sonar Scan

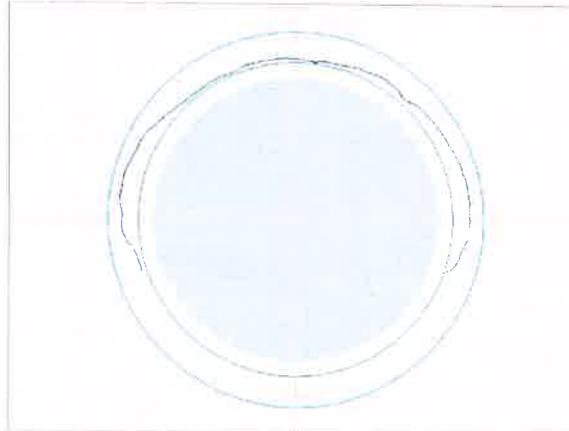
235.2ft Maximum Corrosion - To 5.0"

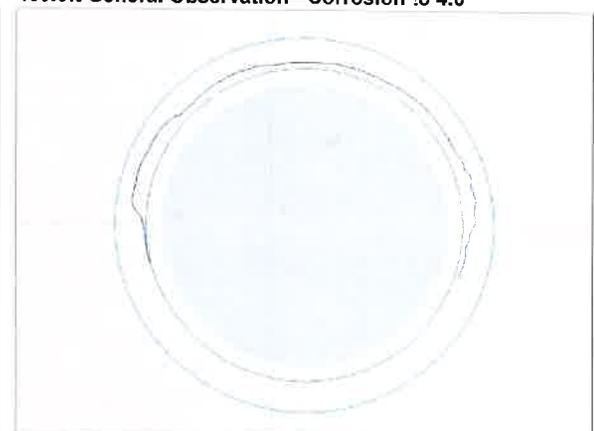
409.9ft General Observation - Corrosion to 4.0"

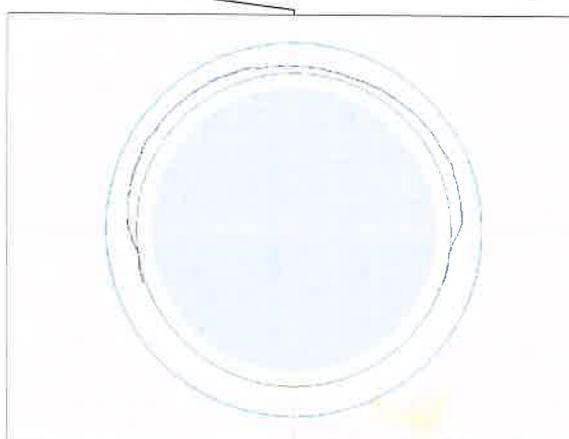
444.9ft General Observation - Corrosion to 3.7"

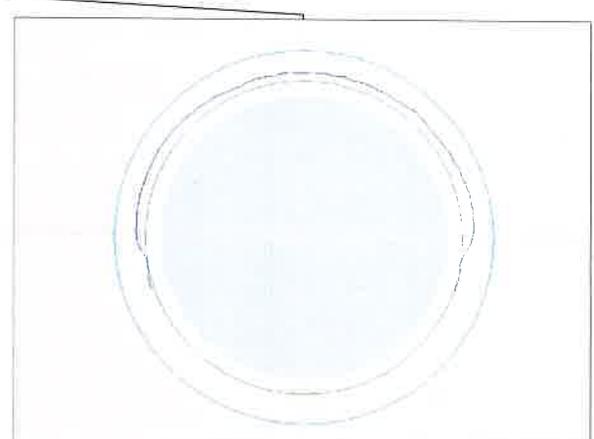
555.2ft General Observation - Corrosion to 3.4"

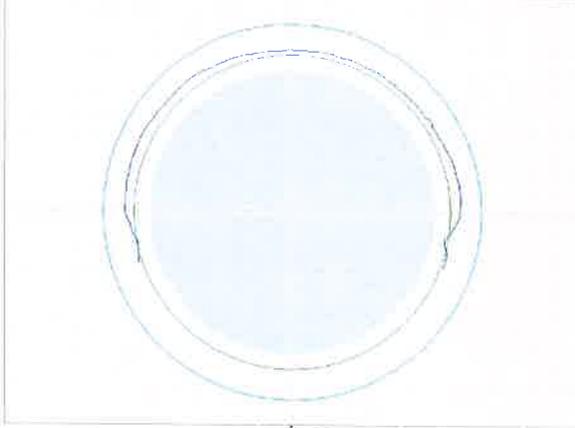
732.5ft General Observation - Corrosion to 2.6"

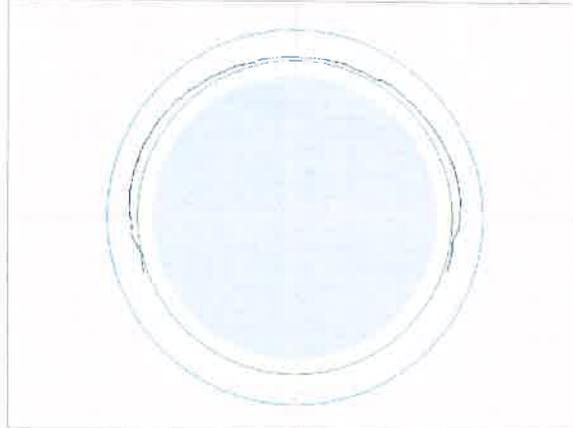
874.9ft General Observation - Corrosion to 2.4"

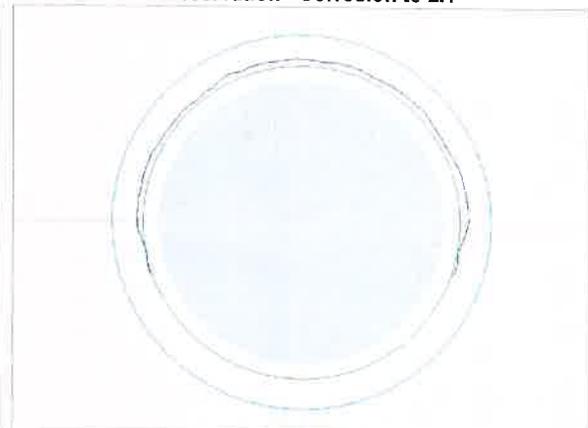
1003ft General Observation - Corrosion to 2.1"

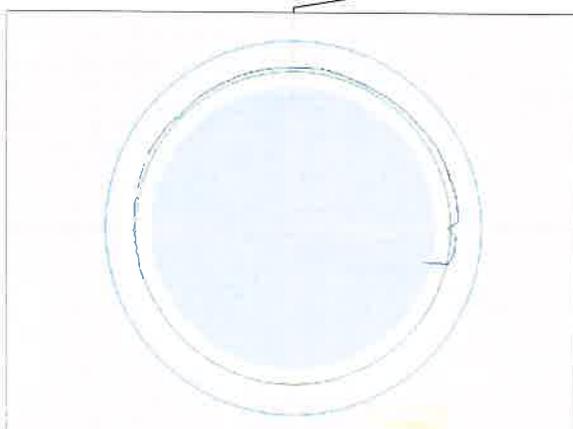
1084.4ft General Observation - Corrosion to 2.4"

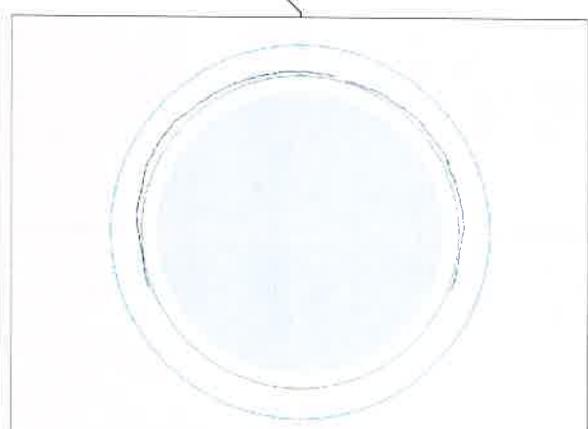
1214ft Note - Profile distorted by bend in pipe until 1310ft

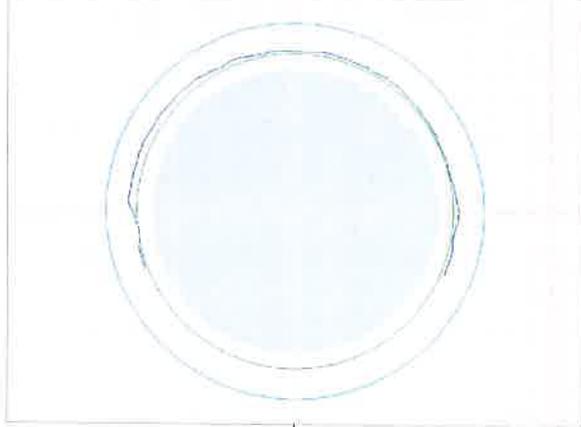
9.7ft General Observation - Corrosion to 2.2"

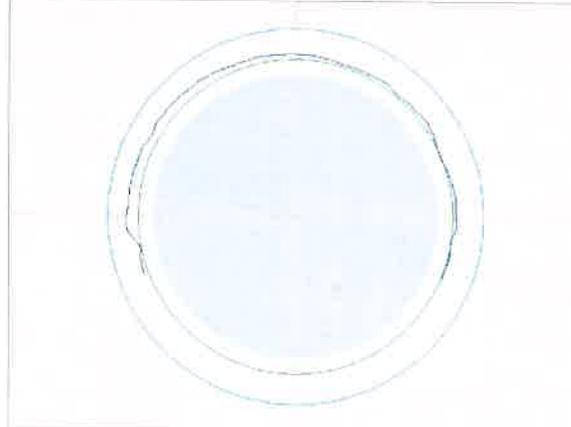
14.9ft Maximum Corrosion - To 3.1"

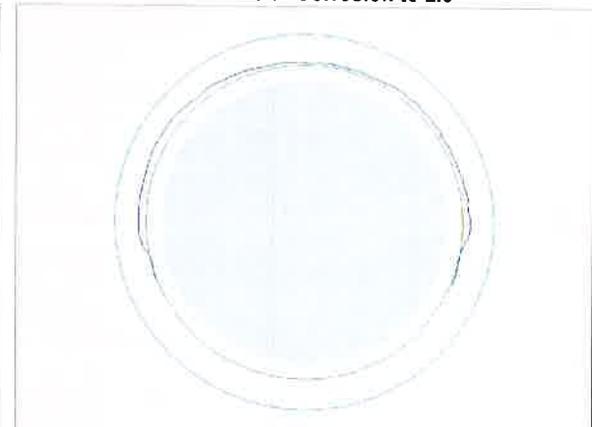
18.7ft General Observation - Corrosion to 2.3"

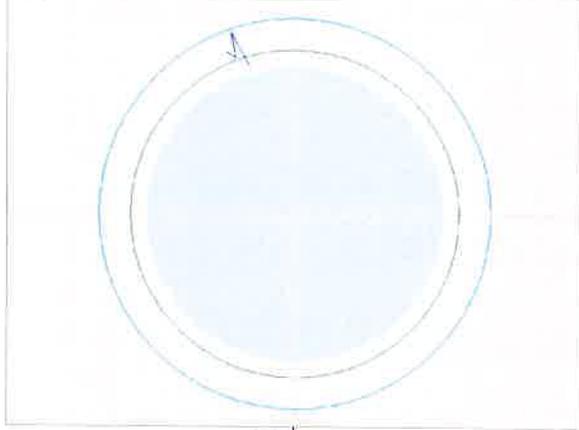
237.5ft Maximum Corrosion - To 5.7"

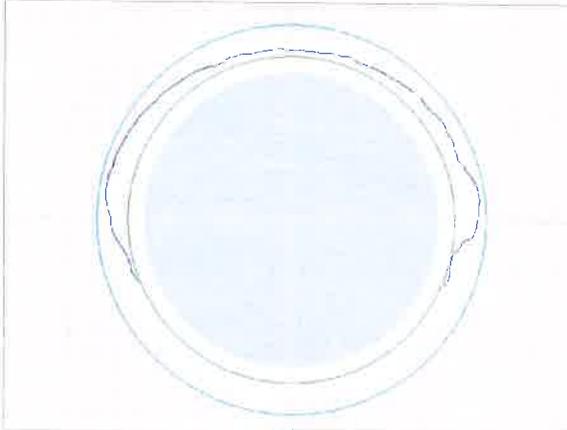
292.9ft General Observation - Corrosion to 5.6"

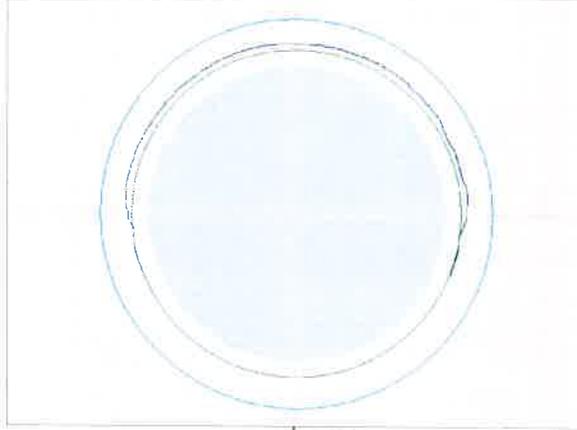
972.8ft General Observation - Corrosion to 1.7"

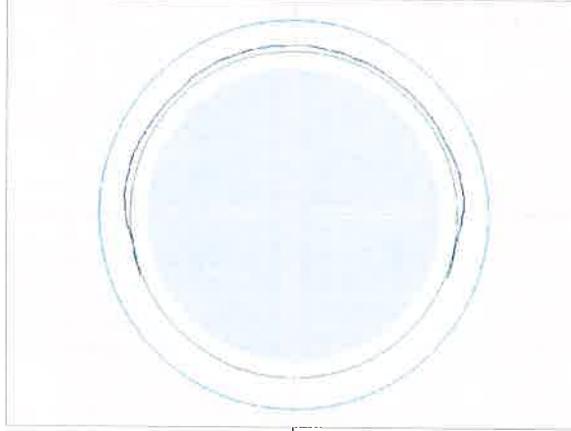
1101.1ft General Observation - Corrosion to 1.6"

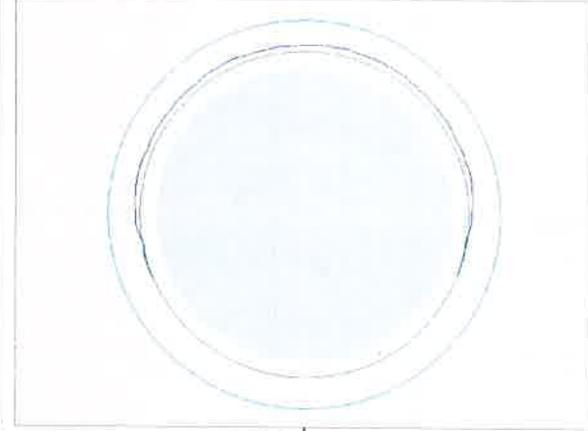
1236.3ft General Observation - Corrosion to 1.6"

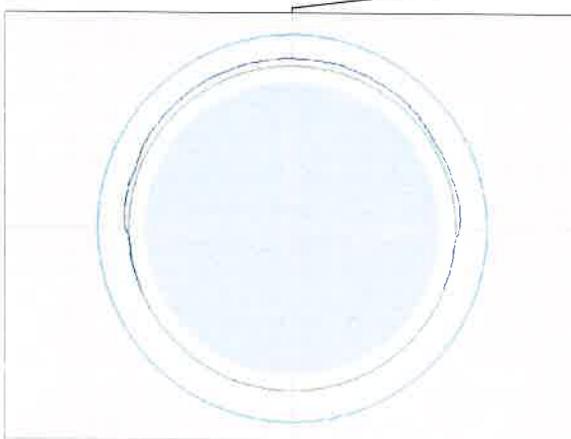
1427.2ft General Observation - Corrosion to 1.9"

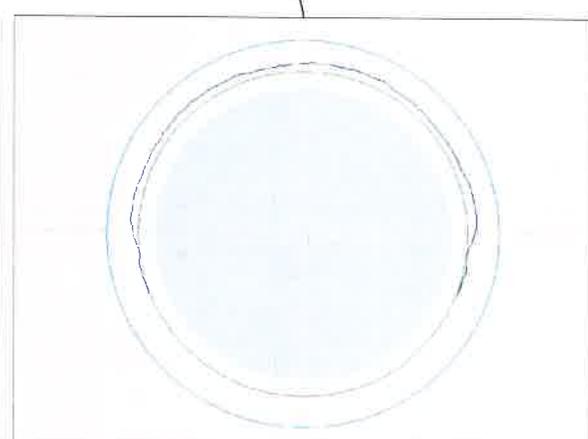
1541.6ft General Observation - Corrosion to 1.7"

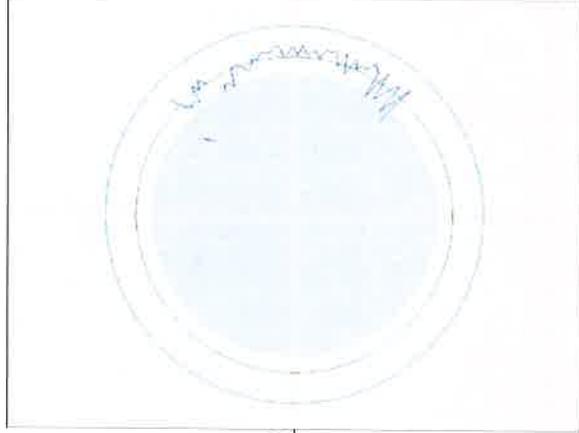
276.2ft Maximum Corrosion - To 6.1"

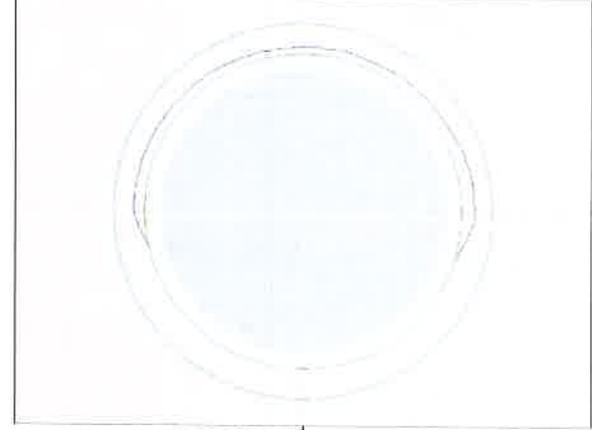
433.9ft General Observation - Corrosion to 3.3"

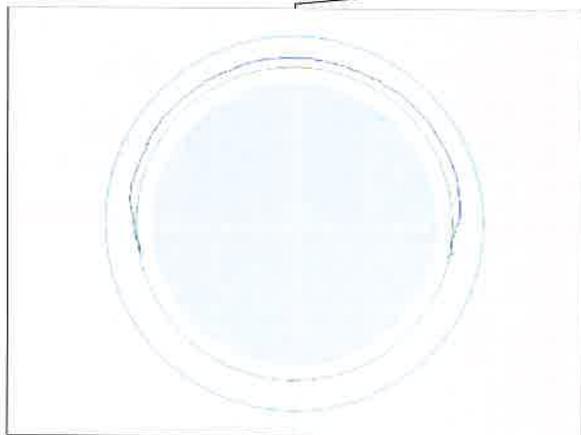
863.6ft General Observation - Corrosion to 2.7"

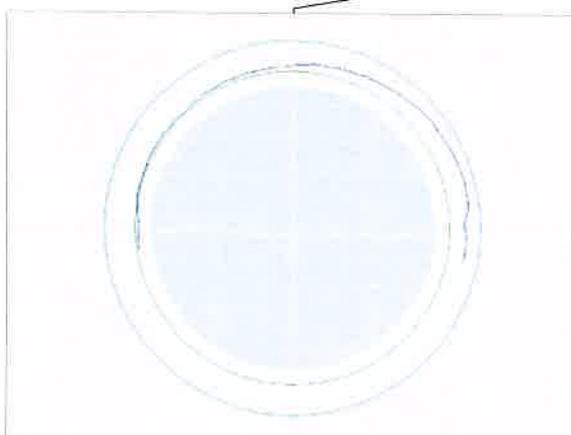
1212.9ft Note - Profile distorted briefly by bend in pipe

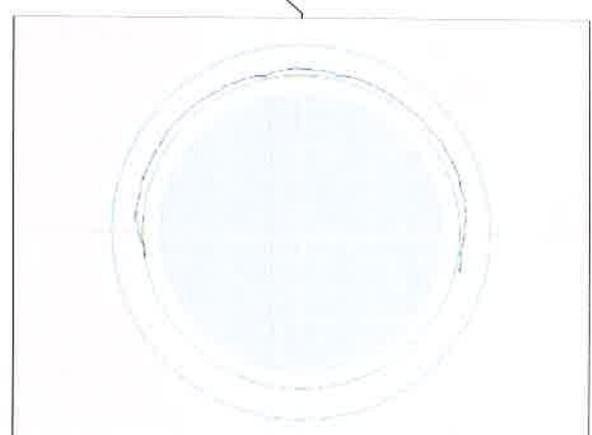
1446.3ft General Observation - Corrosion to 2.3"

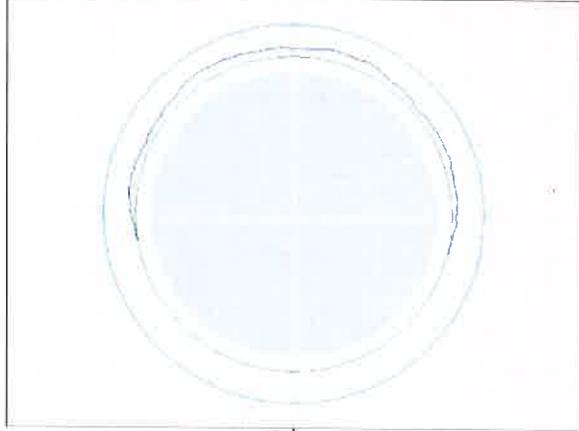
14.6ft Maximum Corrosion - To 3.1"

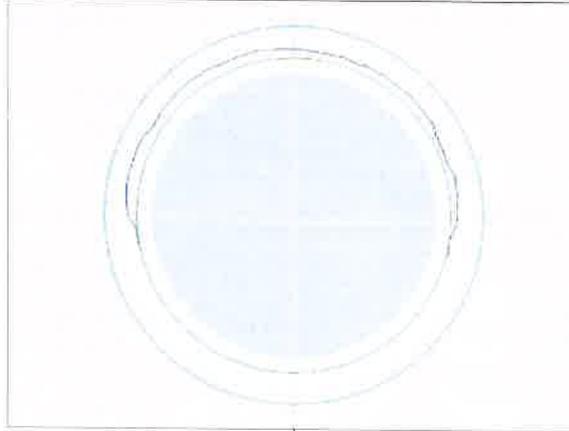
21.1ft General Observation - Corrosion to 3.0"

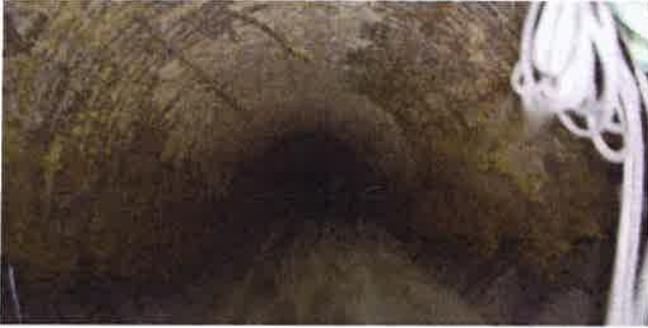
Code: **SRV**
Description: **Surface Reinforcement Visible**

Distance (ft): **.0**
Structural Grade: **5**
O&M Grade: **0**
Clock Start/From: **8**
Clock To: **4**
1st Value:
2nd Value:
Value Percent:
Continuous Index: **S01**
Within 8" of Joint:
Remarks:

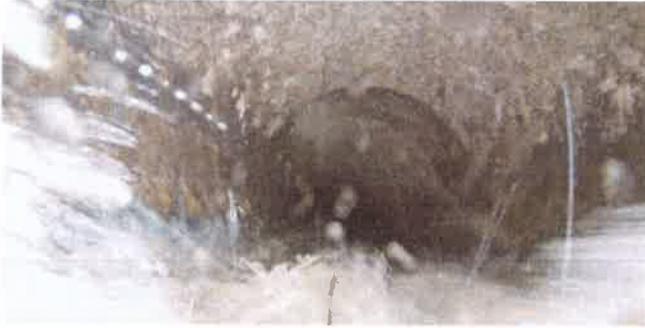
Code: **SAP**
Description: **Surface Aggregate Projecting**

Distance (ft): **89.3**
Structural Grade: **3**
O&M Grade: **0**
Clock Start/From: **8**
Clock To: **4**
1st Value:
2nd Value:
Value Percent:
Continuous Index: **S03**
Within 8" of Joint:
Remarks:

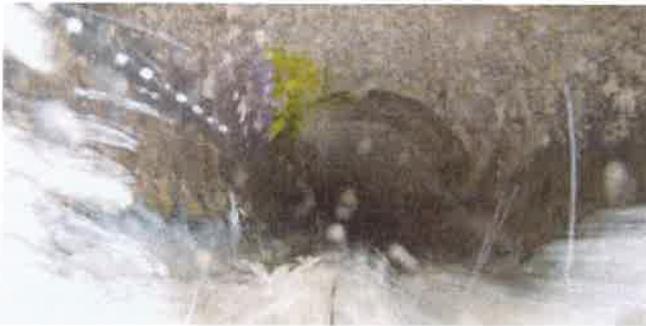
Code: **DAGS**
Description: **Deposits Attached Grease**

Distance (ft): **89.3**
Structural Grade: **0**
O&M Grade: **2**
Clock Start/From: **8**
Clock To: **4**
1st Value:
2nd Value:
Value Percent: **5**
Continuous Index: **S02**
Within 8" of Joint: **NO**
Remarks:

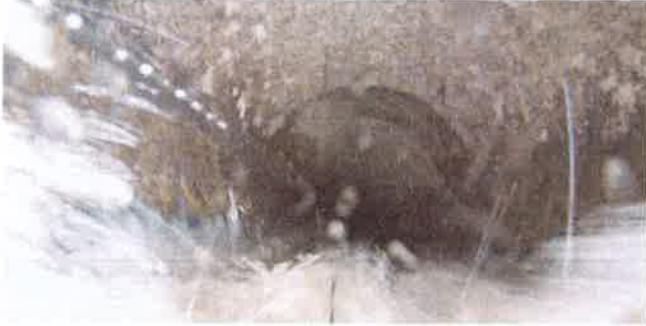
Code: **SRV**
Description: **Surface Reinforcement Visible**

Distance (ft): **89.3**
Structural Grade: **5**
O&M Grade: **0**
Clock Start/From: **8**
Clock To: **4**
1st Value:
2nd Value:
Value Percent:
Continuous Index: **F01**
Within 8" of Joint:
Remarks:

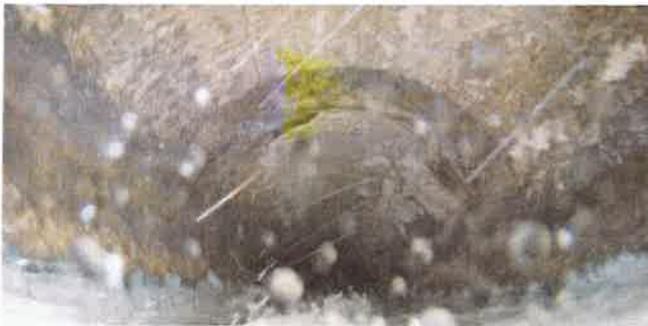
Code: **SRV**
Description: **Surface Reinforcement Visible**

Distance (ft): **146.1**
Structural Grade: **5**
O&M Grade: **0**
Clock Start/From: **10**
Clock To: **2**
1st Value:
2nd Value:
Value Percent:
Continuous Index: **S04**
Within 8" of Joint:
Remarks:

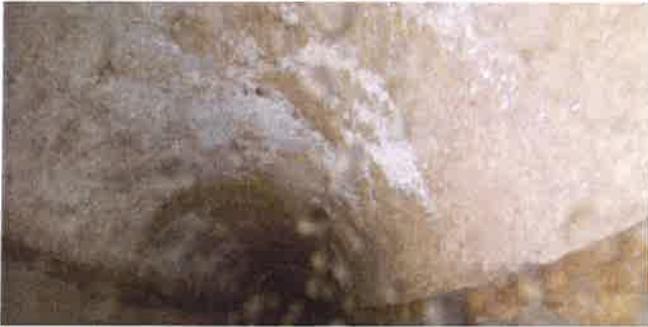
Code: **SRV**
Description: **Surface Reinforcement Visible**

Distance (ft): **968.6**
Structural Grade: **5**
O&M Grade: **0**
Clock Start/From: **10**
Clock To: **2**
1st Value:
2nd Value:
Value Percent:
Continuous Index: **F04**
Within 8" of Joint:
Remarks:

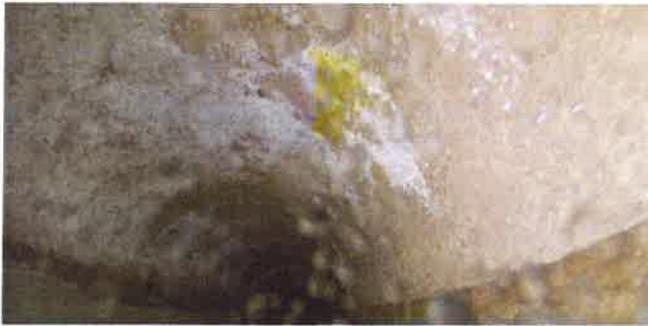
Code: **DAGS**
Description: **Deposits Attached Grease**

Distance (ft): **968.6**
Structural Grade: **0**
O&M Grade: **2**
Clock Start/From: **8**
Clock To: **4**
1st Value:
2nd Value:
Value Percent: **5**
Continuous Index: **F02**
Within 8" of Joint: **NO**
Remarks:

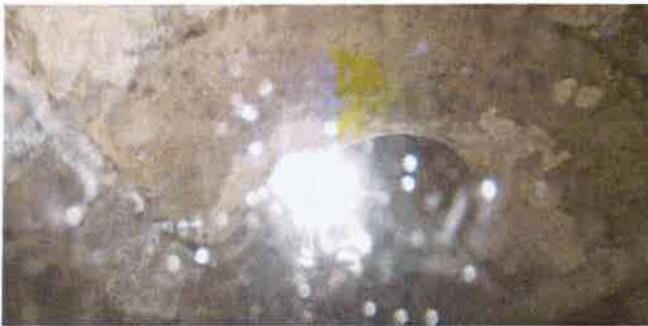
Code: **SAP**
Description: **Surface Aggregate Projecting**

Distance (ft): **1821.5**
Structural Grade: **3**
O&M Grade: **0**
Clock Start/From: **8**
Clock To: **4**
1st Value:
2nd Value:
Value Percent:
Continuous Index: **F03**
Within 8" of Joint:
Remarks:
