**DISTRICT OF COLUMBIA  
WATER AND SEWER AUTHORITY**

**Sewer Investigation:  
Bloomingdale Neighborhood**

**Final**

**October 2006**

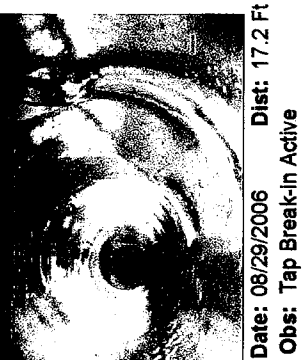
Date: 08/29/2006 Dist: 17.2 Ft  
Obs: Tap Break-in Active

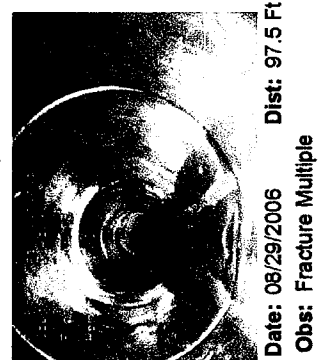
Date: 08/29/2006 Dist: 97.5 Ft  
Obs: Fracture Multiple

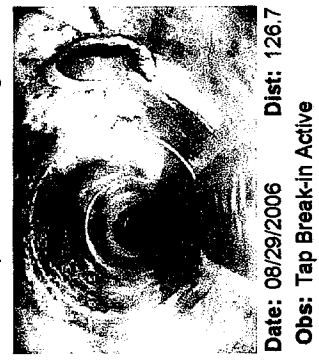
Date: 08/29/2006 Dist: 126.7 Ft  
Obs: Tap Break-in Active

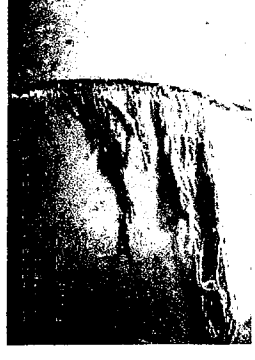
Date: 08/01/2006 Dist: 79.6 Ft  
Obs: Roots Fine Joint

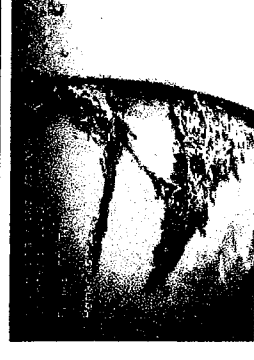
Date: 08/01/2006 Dist: 30.3 Ft  
Obs: Roots Fine Joint

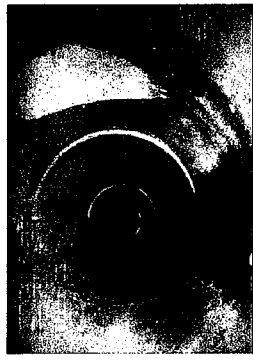
Date: 08/29/2006 Dist: 119.1 Ft  
Obs: Tap Break-in Active

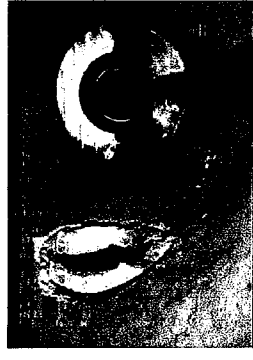
Date: 08/29/2006 Dist: 126.6 Ft  
Obs: Tap Break-in Active
